# City Vista Garages

Post-Tensioned Slab Evaluation | Pittsburgh, PA

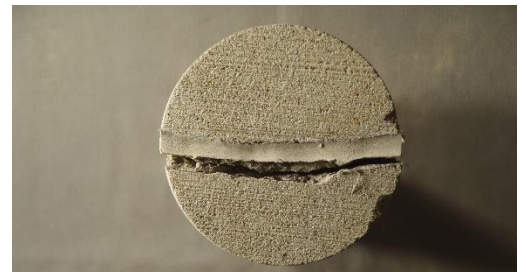
WJE No. 2016.4271  
Sample ID CORE 4-F-2

WJE reviewed original construction documents, observed on-site conditions, and performed petrographic studies on several concrete core samples extracted from the elevated post-tensioned slab. Petrography indicated that the full-depth cracks through the elevated slab formed after the concrete developed a firm bond between the paste and the aggregates. Additionally, crack mapping of elevated slab conditions suggested one-sided restraint of two of the three garages. The crack patterns were consistent with the location of a lower level retaining wall at the two affected garages. WJE concluded that the lower level retaining walls were causing restraint of the elevated slab, which did not allow for adequate transfer of the post-tensioned forces. Repair recommendations were provided to repair cracks and to reduce the amount of water leakage to the lower level of the garages.
