Trimont Condominiums

Facade Condition Assessment | Pittsburgh, PA

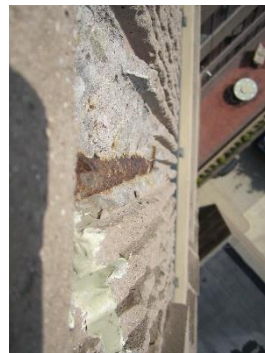
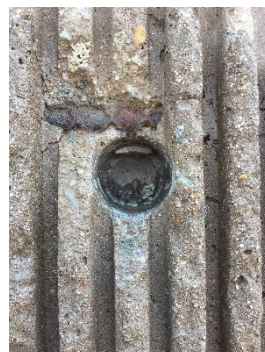
Concrete spalls throughout the facade appeared to be directly related to corrosion of the embedded reinforcement. The incipient spalls observed at many locations presented a risk of falling debris to pedestrian and roof areas below. Field observations of reinforcement cover dimensions revealed that reinforcement bars were located near the exterior surface of the concrete in numerous locations. The corrosion of the embedded steel reinforcement did not appear to be caused by chloride admixtures within the concrete, but rather by carbonation of the concrete from natural atmospheric exposure of the building.

Recommendations were provided to conduct a more detailed examination in preparation of developing a comprehensive repair program.
