# Assessment and Repair of Historic Plaster Systems

## (Part 2)

### Michael J. Howlett Building

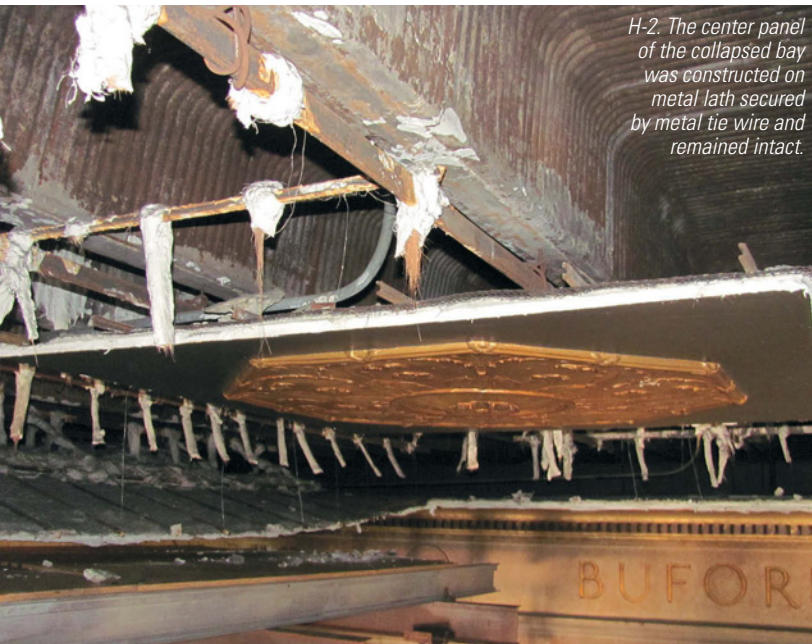
H-2. The center panel of the collapsed bay was constructed on metal lath secured by metal tie wire and remained intact.

During the investigation, it was determined that the ornate plaster ceiling was actually built using two distinct assemblies. Relatively flat center panels in each bay were constructed of plaster applied to metal lath, and the metal lath was secured by wire ties to light-gauge iron framing above. This system was found to be robust; in fact, the center of the collapsed bay remained intact while the remainder of the ceiling fell around it (Figure H-2).

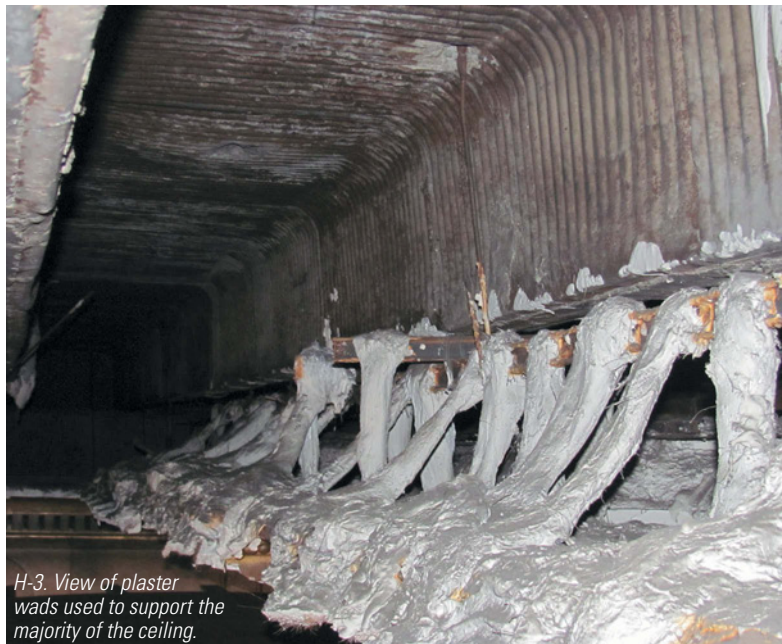
H-3. View of plaster wads used to support the majority of the ceiling.

However, the majority of the ceiling was found to consist of fiber-reinforced pre-molded gypsum plaster elements (without lath), suspended from the iron framing above using plaster wads (Figure H-3). Plaster wads are hand-formed, tube-shaped elements reinforced with fibers. During construction, the wet plaster wads were applied to suspend the molded plaster elements. When the plaster wads dried, they provided a rigid support for the ceiling. Over time the plaster wads cracked, resulting in the collapse of the plaster ceiling.

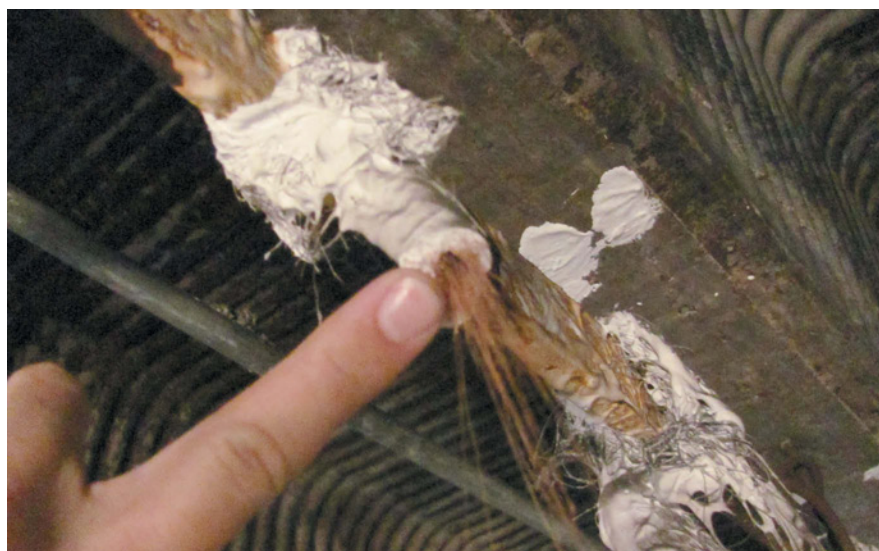
Laboratory analysis determined that the fibers were jute, a plant fiber commonly used for plastering applications. However, as the fibers dry out over time, they gradually become brittle and

H-4. At the area of the collapse, plant fibers at many wads were found to be poorly integrated with the plaster.

lose strength. The investigation also revealed that the fibers within each wad were not well integrated with the plaster (Figure H-4); this deficiency in the original installation may have contributed to the gradual loss of strength and the failure of the plaster wads. The failure of one wad increased the loads applied to other adjacent wads, leading to progressive failure of the ceiling support.

Based on our investigation, installation of supplemental safety anchorage was recommended at all remaining portions of the Hall of Flags ceiling. The
