# Second Chances: A New Ceiling for Queen of All Saints

**AUTHORS: TIMOTHY M. CROWE, ALA, SE, PE, ELIZABETH R. PUGH; PEWISS JANNEY, ELSTNER ASSOCIATES, INC.**

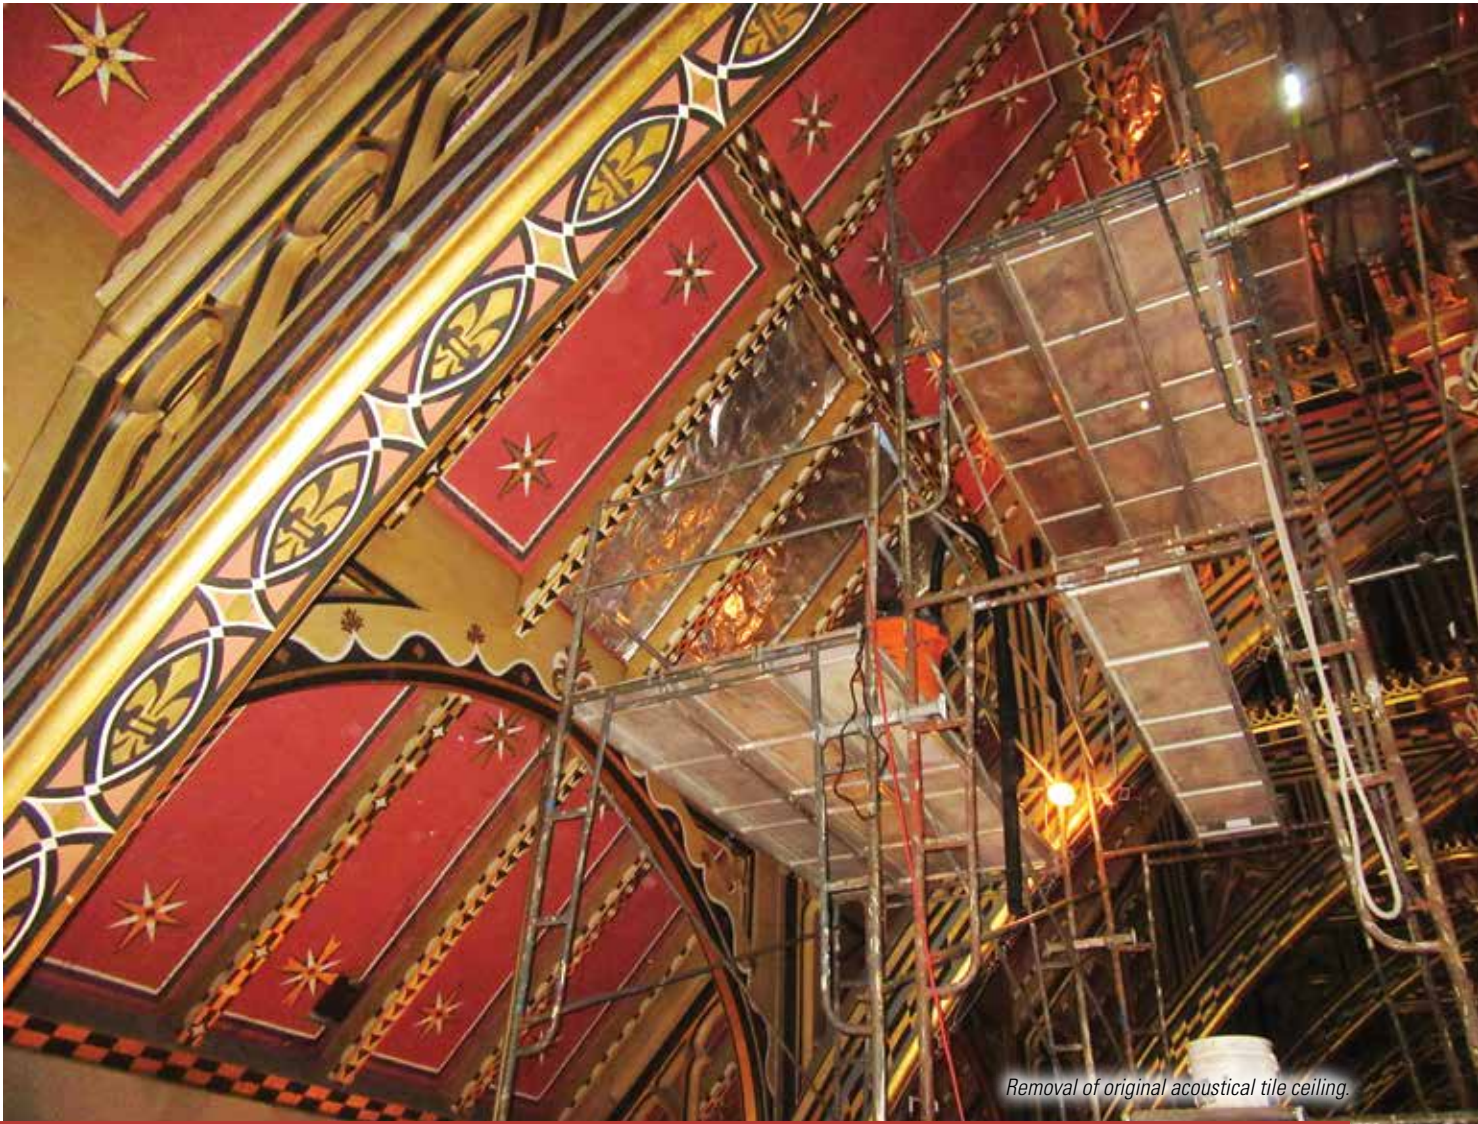
*Removal of original acoustical tile ceiling.*

Recurring issues of ceiling tiles sliding down the concealed spline support were problematic. Apparent

contributing factors included differential movements of the timber roof framing and tiles that exceeded tolerances of the concealed spline support. Despite maintenance efforts, including supplemental nails and sealant, reliable support of the tiles remained difficult. When it became apparent that tiles were at risk of

The replacement ceiling system which was ultimately selected introduced a non-vented compact roof assembly. The surface-mounted vents were sealed with custom fabricated copper closures secured in place and packed with mineral wool insulation. The replacement ceiling panels were comprised of a new system of aluminum honeycomb panels fully adhered to rigid Foamglas insulation. The fully bonded insulation, a cellular glass product very impervious to moisture and noncombustible, controlled potential vibration of the aluminum panels, and the surface

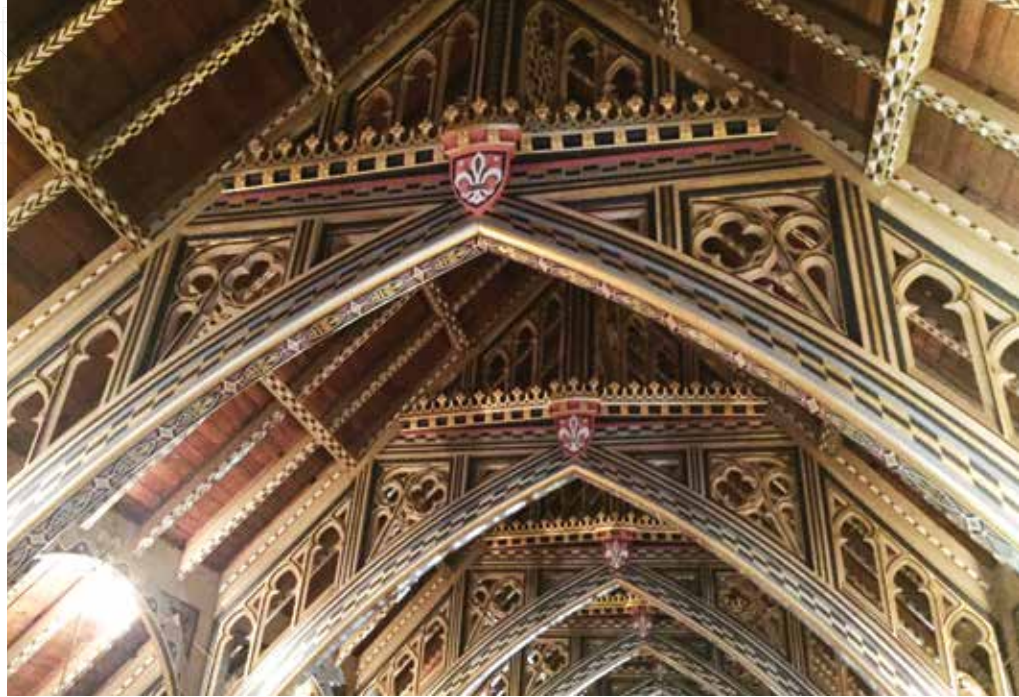
*Exposed wood decking and decoratively painted wood framing.*

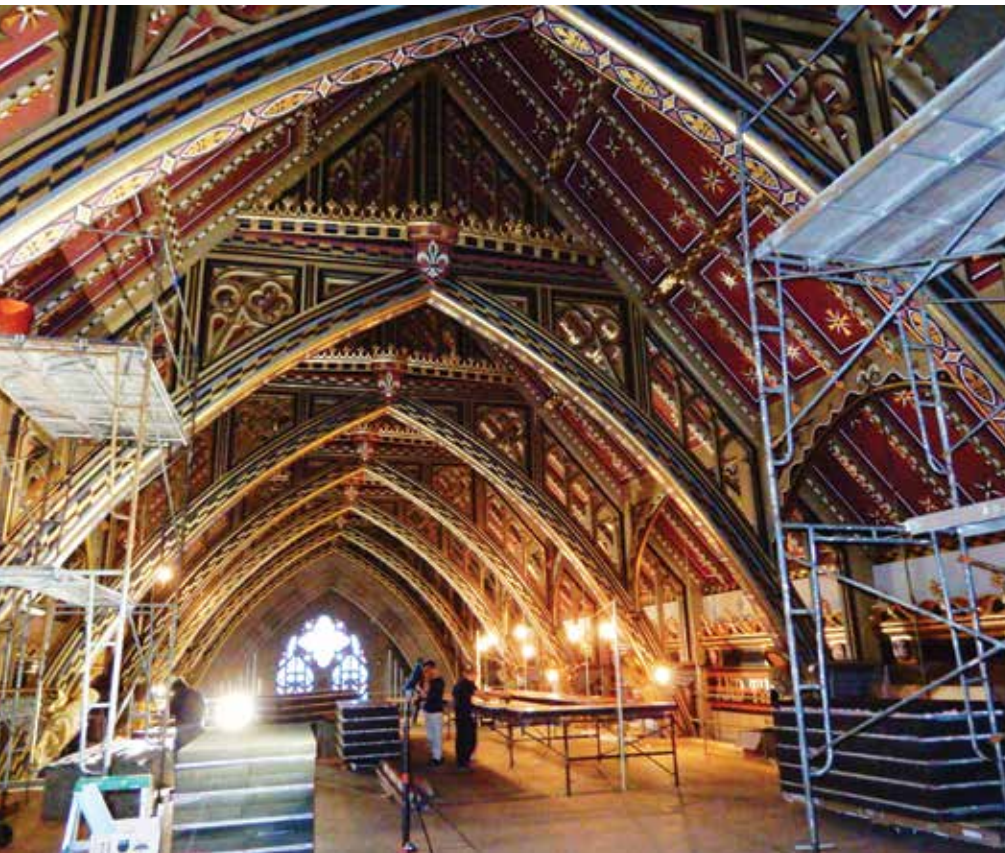
*Painting of prefabricated panels on the scaffold near the ceiling.*

(less absorptive than the original acoustical tile) proved to enhance acoustics within the basilica. Supplemental mineral wool insulation was provided to cushion the top of the adhered panel assemblies to the underside of the roof deck to increase R-value and reduce air voids in the system. Panel perimeters were air sealed with a fire-rated foam and the panels were ultimately held in place with continuous gaskets supported by painted wood trim. The dimensionally stable panel system also allowed for a uniform appearance and finish. DRS created a studio atop a scaffold located approximately 42 feet above the church floor amid the gilded roof structure, which allowed them to paint and apply gilding to custom-fabricated panels on site and replicate the design and patterns of the original ceiling.

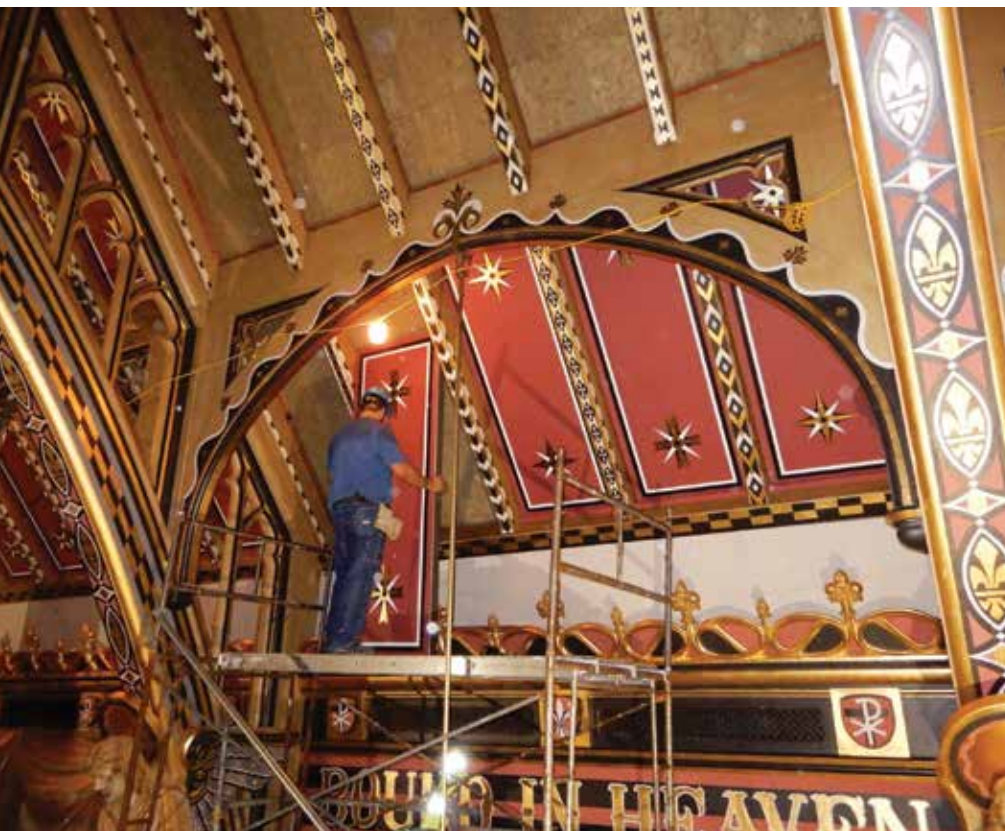
*Panel installation in progress.*

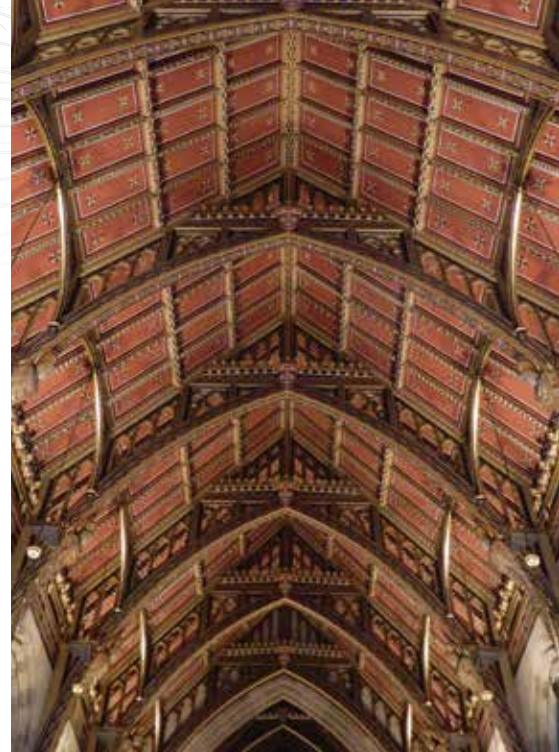
Completed installation of ceiling and scaffold removal.
