FEATURE

Terra Cotta Skyscrapers

By Edward Gerns and Anita Simon

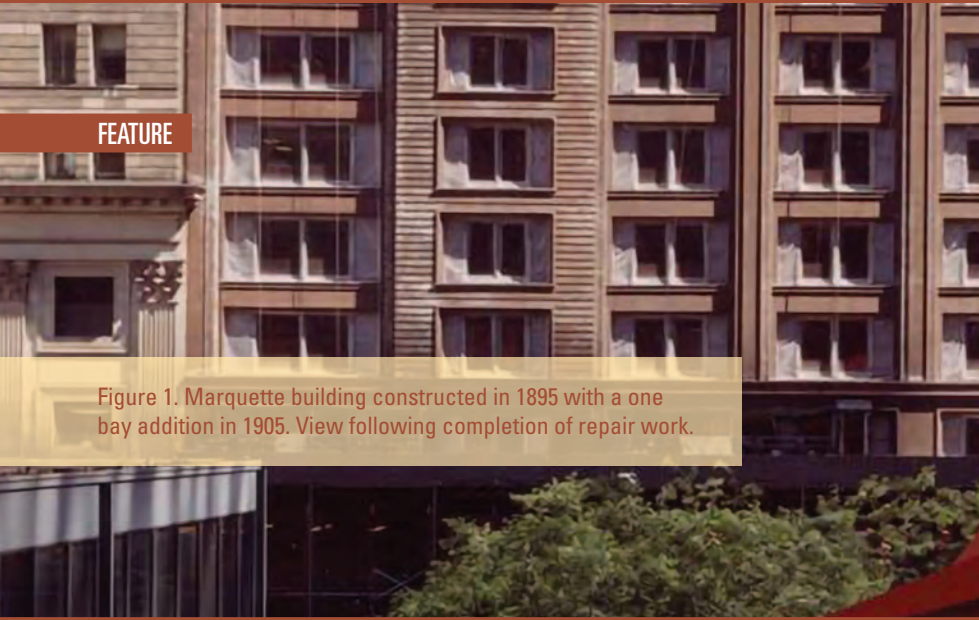
Figure 1. Marquette building constructed in 1895 with a one bay addition in 1905. View following completion of repair work.

One of the earliest of the masonry-clad skyscrapers was designed by architects Holabird and Roche in 1894. The 17-story Marquette building is considered one of the first high-rise buildings constructed with a steel frame structural system and a classic example of the Chicago School aesthetic (Figure 1). The facade of the building is notable for its expression of the underlying steel frame structure. Large window openings extend across nearly the entire width of the structural bays and at typical floors. Continuous projecting brick piers and recessed brick spandrels further emphasize the structural grid. The ornamental street-facing facades of the

Over the course of a 10 year process, numerous exterior restoration projects have been performed on the building. The most significant distress was found at the interface between the reconstructed 17th floor wall system and the original terra cotta cladding at the 16th floor. The reconfiguration of this interface detail resulted in increased moisture infiltration and subsequent corrosion of the embedded steel and distress to the terra cotta. Repairs have included: cleaning the brickwork and terra cotta, selected terra cotta replacement (Figure 4), repointing, and the installation of a new GFRC

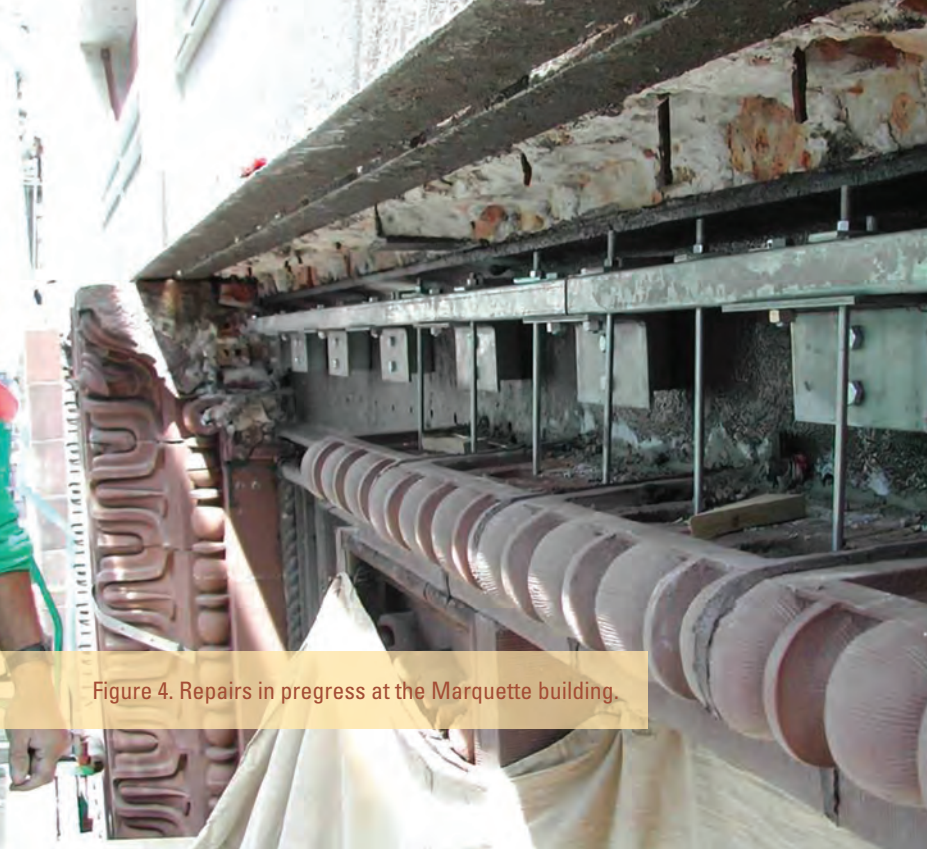
Figure 4. Repairs in progress at the Marquette building.

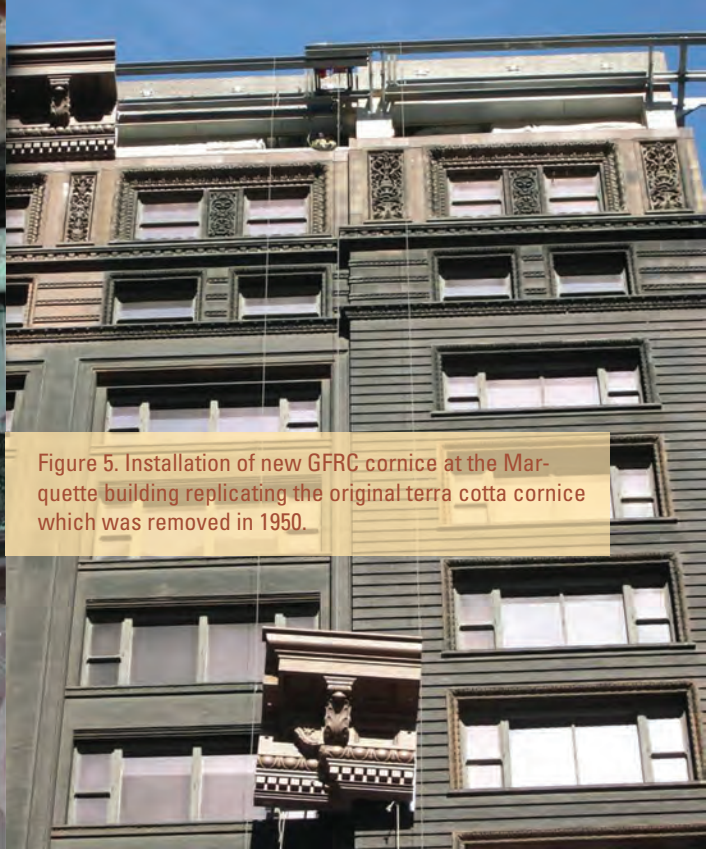
Figure 5. Installation of new GFRP cornice at the Marquette building replicating the original terra cotta cornice which was removed in 1950.

The 17th floor of the main facades of the building was originally clad with a large, projecting terra cotta cornice. In 1950, this cornice was removed and replaced with a flat brick wall. Investigations of the facade found that with the exception of the distress resulting from the removal of the cornice and subsequent poor detailing at the new 17th floor cladding, the majority of the embedded steel was in remarkably good condition. In many instances the original lead based primer remained intact. Many possible explanations could explain the lack of distress. Mortar joints were typically less than 1/8 inch wide, known as butter joints, and the steel which supported the terra cotta tended to be embedded deeper in the wall and typically encapsulated within the backup brickwork, resulting in a configuration that was less problematic relative to areas with greater exposure to cyclic moisture.

(glass fiber reinforced concrete which is sometimes used as a substitute material to replicate terra cotta) cornice which replicated the original cornice which had been removed (Figure 5), and restoration of the original wood windows.

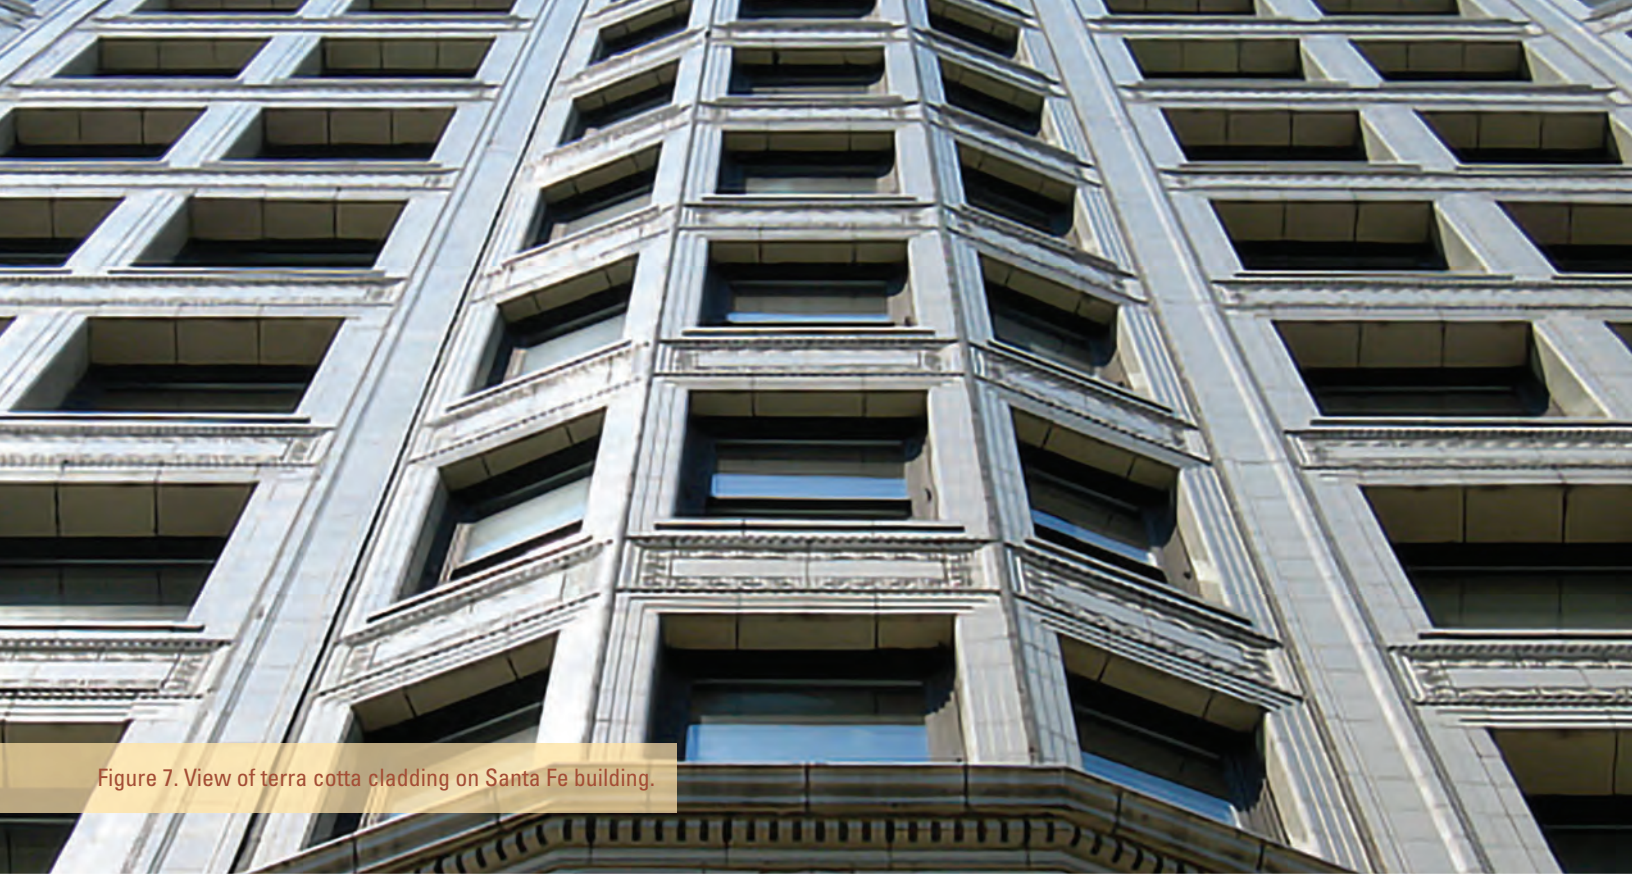
Figure 7. View of terra cotta cladding on Santa Fe building.

above. Terra cotta masonry above the bay windows is notched to accommodate and bear on the horizontal leg of the shelf angle (Figure 7).

Investigation revealed that while corrosion of the embedded steel was not significant, deterioration had occurred including cracking and displacements as a result of the expansive forces of corrosion by-product. The combination of initial moisture expansion, thermal cycles and frame shrinkage resulted in significant accumulation of compression stresses within the cladding system. These stresses resulted in cracking and localized displacements of the terra cotta.

To relieve compressive stresses within the terra cotta cladding, horizontal joints were cut within the piers immediately below the shelf angle at each floor. Subsequent repairs included replacement of significantly deteriorated terra cotta with new terra cotta units. Selected salvageable units were removed, repaired and reinstalled, and through-wall anchors were installed at some of the cracked units for stabilization purposes. Finally, due to a combination of conditions, all of the terra cotta units at one of the corners were removed, the embedded steel repaired, and the corner was reconstructed with a combination of new and salvaged units.

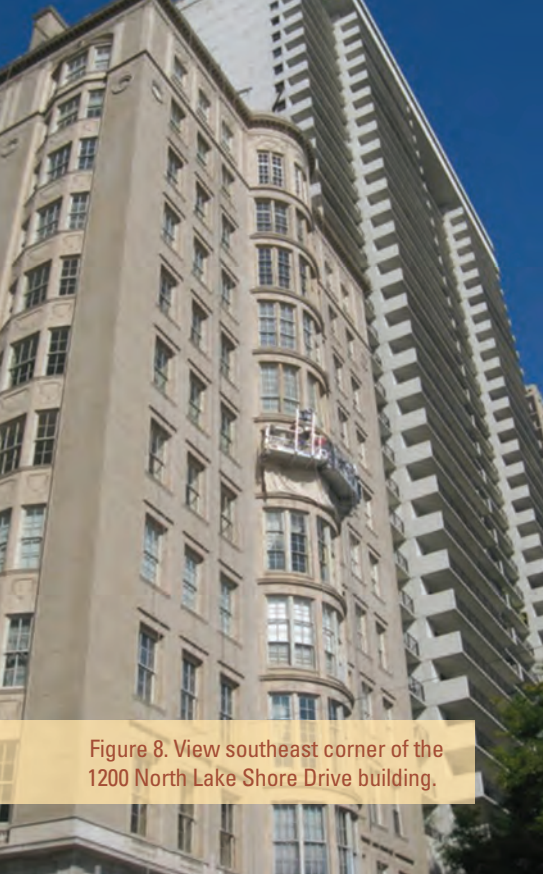
Figure 8. View southeast corner of the 1200 North Lake Shore Drive building.

Investigation revealed that deferred maintenance had resulted in significant water infiltration and subsequent deterioration at the parapet, projecting bays including the L'Orangerie, window lintels, and the corners of the building. These areas are naturally more prone to water infiltration and with the lack of maintenance, significant deterioration of the embedded steel structure had occurred. At many locations corrosion of the steel was so significant that members had lost significant structural capacity. While the underlying steel was significantly deteriorated, in many instances the terra cotta cladding was relatively undamaged because corrosion of the lateral anchorage for the terra cotta had corroded completely with no significant corrosion scale accumulation.

As a result the units had shifted as the structural elements corroded but the units themselves had not been damaged.

Repairs included rebuilding the corners of the building from the 12th floor to the roof and the southeast corner was rebuilt from the third floor upward. Additional shelf angles were installed to provide continuous support of the masonry and the exposed portions of the existing steel framing was cleaned and painted (Figure 10). The cracked terra cotta mullion units at the three projecting bays, including the L'Orangerie, were removed and replaced with new matching terra cotta units. The mullions were anchored using stainless steel brick veneer ties modified to support the terra cotta back to the existing structural tees. The visibly cracked terra cotta units at the spandrels of the projecting bays were replaced with terra cotta units to match. Displaced but intact salvageable terra cotta units were repaired and reinstalled; however, when units could not be repaired, replacement terra cotta units were fabricated to match existing. Upon removal of the terra cotta mullions it was discovered that many of the terra cotta spandrel units showing no signs of visible distress had experienced face shearing and concealed cracking because of the support condition of the

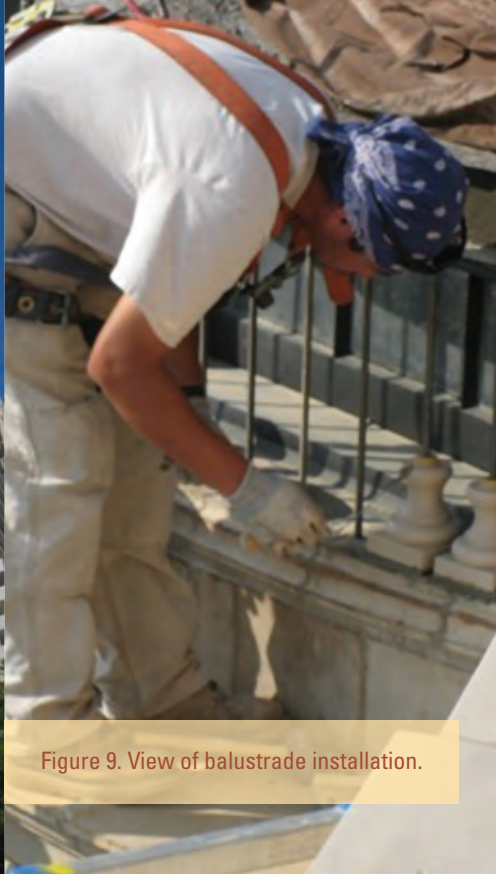
Figure 9. View of balustrade installation.

existing steel as well as the weight of the cast iron railings bearing on the terra cotta. As a result, the terra cotta units were replaced to match existing and additional lateral stainless steel anchorages were installed to help alleviate this condition in the future. All of the exposed steel curved spandrel beams and supplemental steel were cleaned and painted after the removal of the existing terra cotta units. The cracked terra cotta units and adjacent deteriorated brick masonry were removed to repair, clean, and paint the exposed corroded steel lintels. In addition, supplemental steel plates were fastened to the existing steel angles to provide adequate support for the replacement terra cotta and brick masonry. Upon completion of the steel repairs, new terra cotta units and brick masonry were installed to match the existing.

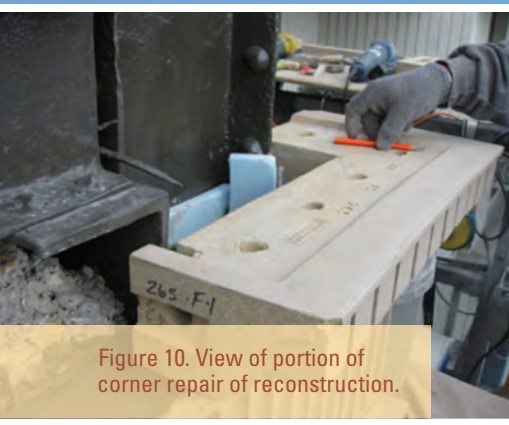
Figure 10. View of portion of corner repair of reconstruction.

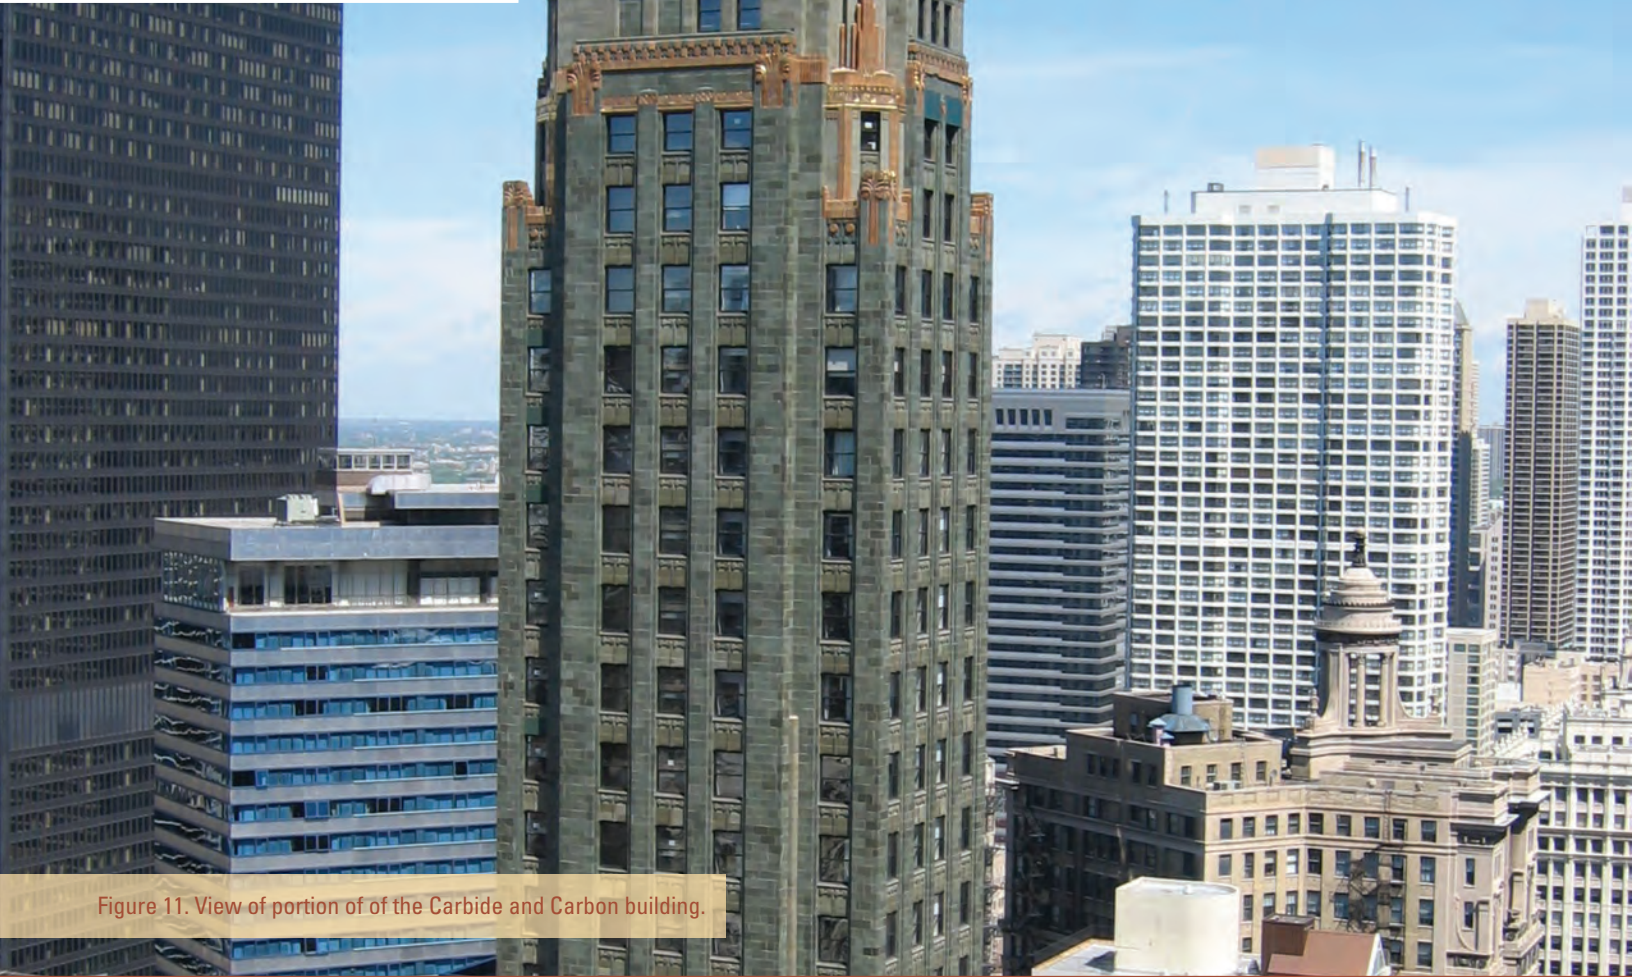
Investigation revealed significant corrosion of the embedded terra cotta lateral anchorage resulting in significant deterioration of terra cotta units including cracking and displacements from the accumulation of corrosion scale. The steel plates which were riveted to the horizontal leg of the support angle for the terra cotta at each floor were typically severely corroded. These conditions were further exacerbated by the stresses due to initial moisture expansion, thermal cycles and frame shrinkage.

Figure 11. View of portion of of the Carbide and Carbon building.

Repairs included cleaning the terra cotta and cutting horizontal joints at regular vertical intervals. New plates were bolted

to the existing steel angles to reestablish support for the cladding. Salvageable units were removed, repaired and reinstalled and significantly deteriorated units were replaced. Terra cotta units which exhibited minor cracking and were not displaced were stabilized in-situ using stainless steel anchors.
