Measuring Up to Steeple Remediation

BY: TIMOTHY M. CROWE, ALA, FAPT, SE, PE, WISS, JANNEY, ELSTNER ASSOCIATES, INC.

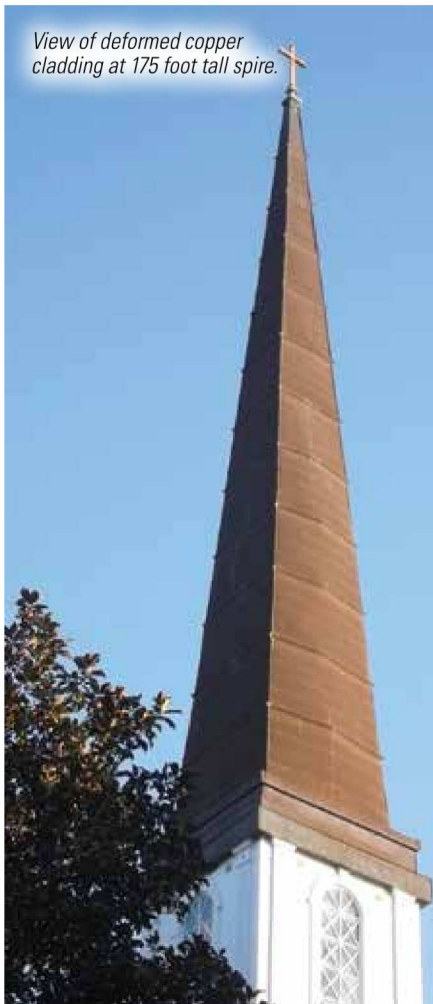
View of deformed copper cladding at 175 foot tall spire.

Structural assessments revealed that the spire's braced steel armature could resist code wind loads. However, plywood sheathing supported by 2x4 wood members secured to the corners of the steel frame comprised the copper-cladding substrate, and was too flexible. When negative wind pressures pulled on the cladding, this sheathing assembly was vulnerable to significant deflections with even moderate wind loads. Deflections resulted in crimping of the metal and the copper sheets experienced tears and deformations. Further inspection revealed that the copper had been installed over the plywood without underlayment. The lack of an underlayment subjected the plywood to moisture from recurring condensation on the inside face of the

copper when dew-point temperatures are experienced — a frequent occurrence in the southeast United States region. Wet plywood reduced pull-out capacities of the cladding fasteners and promotes rot, further weakening cladding support. Thus, repairs that include a stiffer sheathing support and a properly detailed underlayment were recommended with cladding remediation.

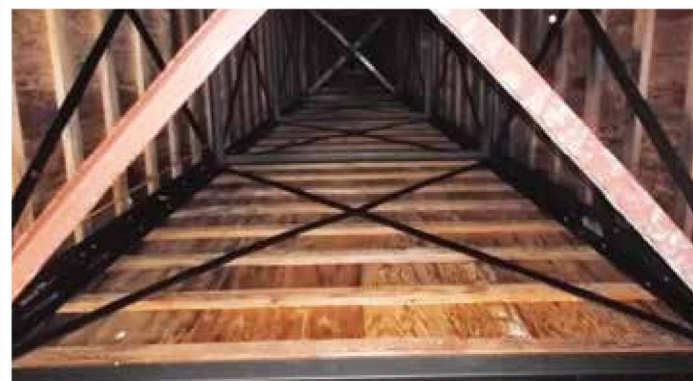
Interior view of spire sheathing construction around the braced steel framing.

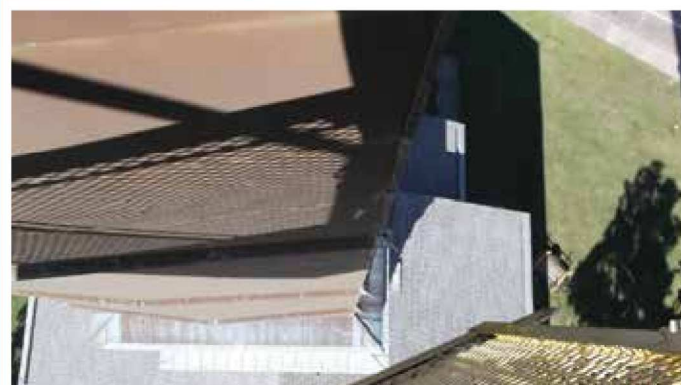
View looking down deformed spire cladding from crane basket.

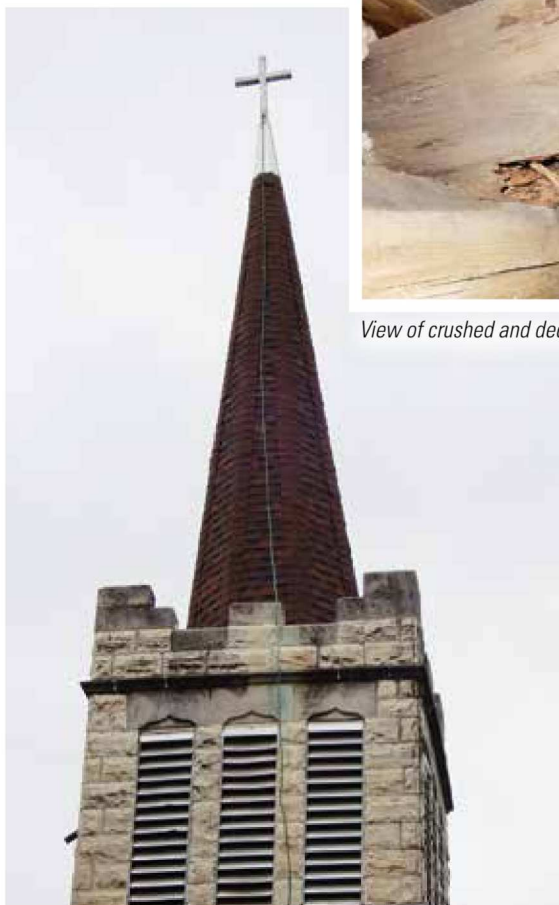
Partial view of leaning spire at 1895 church in Lemont.

corresponding leaning of the spire. Though the stick-framed spire generally remained intact, the extent of framing decay demonstrated that moisture infiltration had been ongoing at its base. Support deterioration and spire displacement posed significant safety concerns regarding whether the spire may collapse under even moderate wind loads.

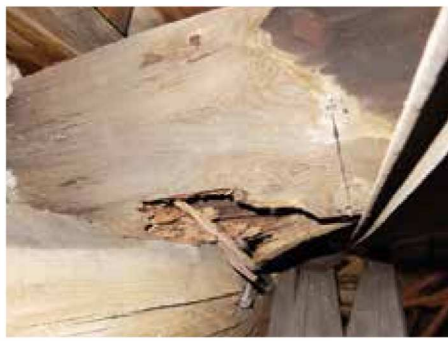
The Lemont church tower and belfry is a stone masonry structure with a wood framed spire built around 1895, and is 90 feet tall. The spire is clad with asphalt shingles and adorned with a metal cross. Concerns regarding apparent decay at the belfry roof framing prompted our inspection. Our investigation revealed that advanced decay of the timber framing led to member crushing and

View of crushed and decayed timber.

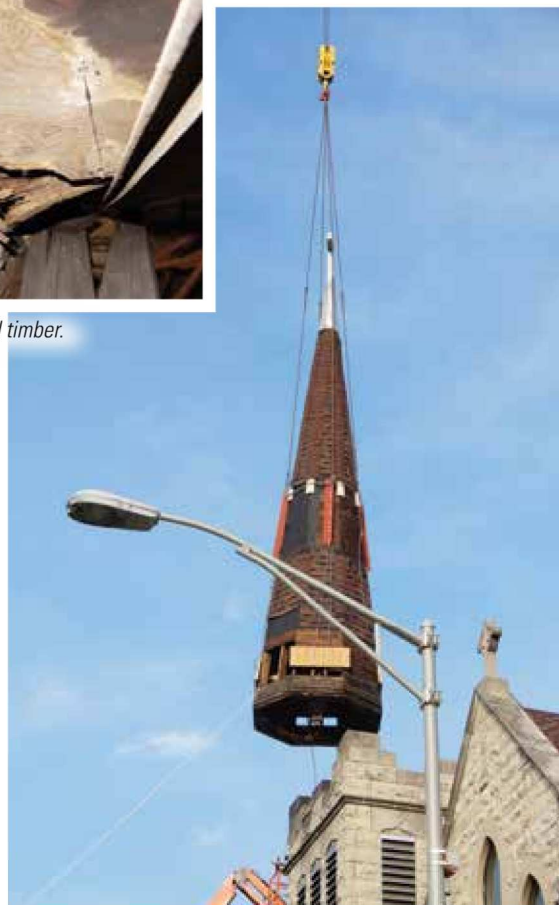
Removal of spire for future restoration.

Temporary stabilization was not practical as shoring systems would have hampered church functions, obstructed future repair implementation, and was costly. Thus, the objective was to develop a strategy to immediately remove and salvage the spire for future restoration.

Temporary roof details were also prepared to enclose and protect the belfry until restoration work could be performed. Removal work included the extraction of rotted timbers and bell-ringing mechanisms. Detaching the spire revealed that the sole anchorage of the 35-foot tall wood cone was a single 1/2-inch diameter bolt through the spire mast and a strap to the decayed framing. Consequently, all parties involved were very relieved when this element was safely secured to the ground. Modifications of this spire attachment along with enhanced water management at the spire base will be necessary as part of the restoration effort.

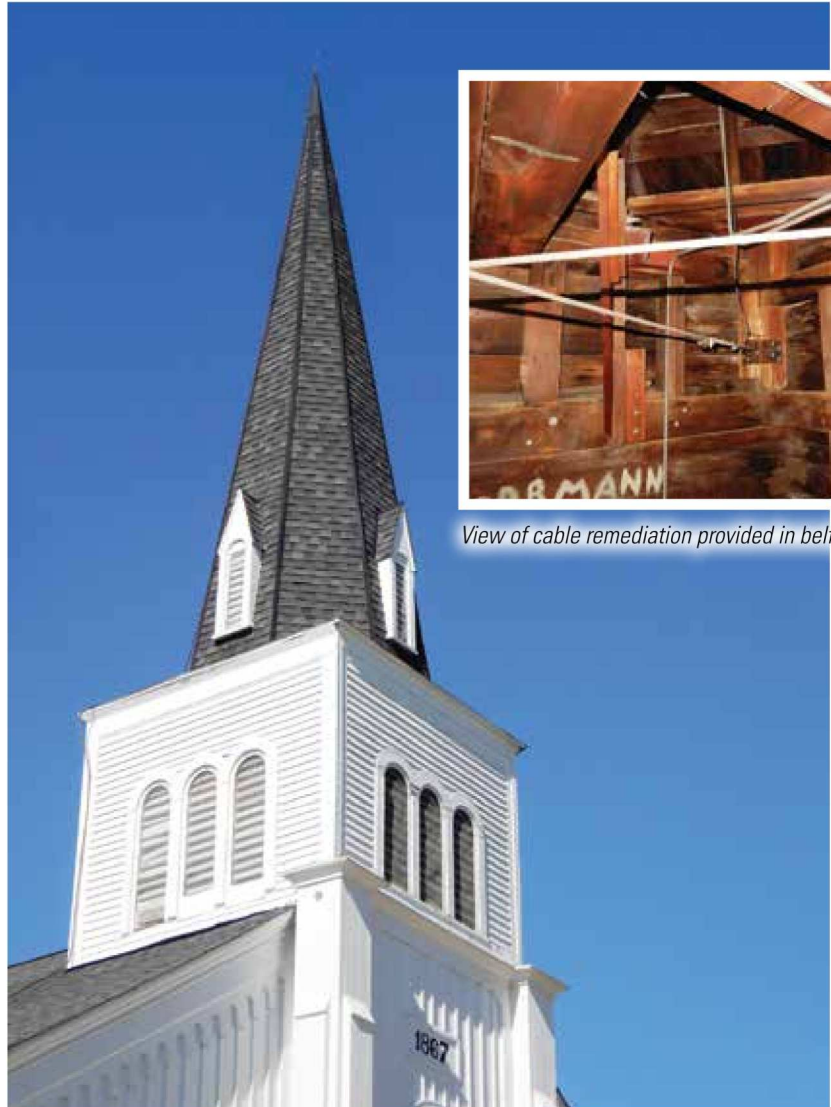
View of cable remediation provided in belfry.

The tower was dry, well ventilated, and generally intact. However; damaged framing members and missing bracing components had impaired the structure's ability to resist lateral loads. Though the steel cable installations may have been performed to help correct framing deficiencies, structural analyses revealed the cables lack the necessary stiffness to effectively resolve load paths. Consequently, the structure was vulnerable to lateral movement when subjected to moderate wind events. These movements damaged to the exterior wood cladding, created flashing system breaches and introduced paths for moisture infiltration.

Recommended repairs included properly reinforcing the structure to provide a reliable load paths against wind loads, replace the metal roofing within the belfry, and repair belfry louvers and affected cladding. Further examination of the spire roofing was also recommended so that asphalt shingle issues and flashing be corrected as appropriate.
