PROJECT PROFILE

Historic Office Building

Structural Assessment and Repair Design | Wichita Falls, TX

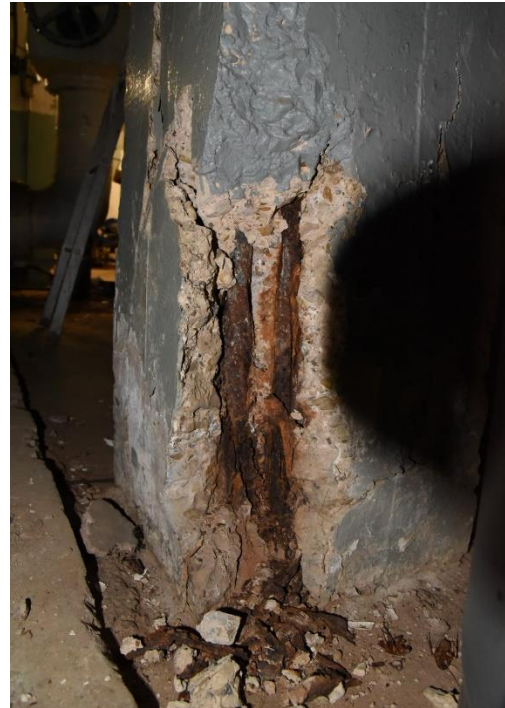
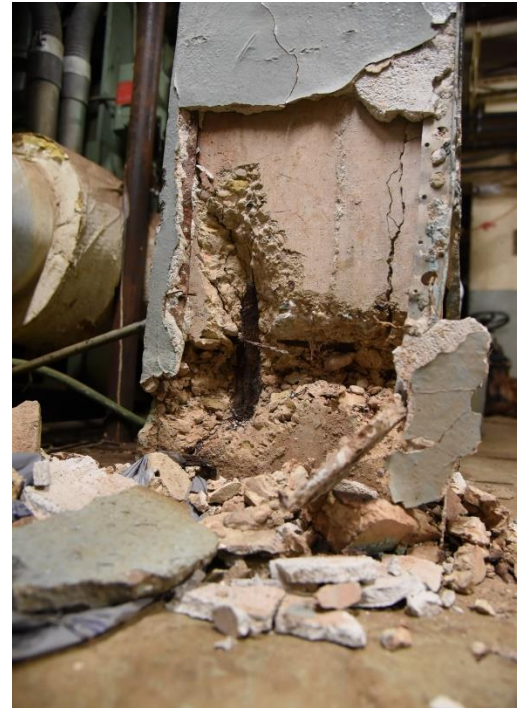
The three distressed columns each originally had a concrete cross section measuring about 12 inches by 12 inches. The columns supported a cast-in-place concrete filigree slab for the first floor. Prior renovations removed the roof load from these columns.

WJE was engaged to investigate and develop repair documents for three small concrete columns in the lowest portion of this historic building's basement. The columns supported the first floor structure and exhibited deterioration near the basement floor slab.

WJE investigation determined that the deteriorated columns did not have significant reserve capacity beyond the existing loads imposed on them. The deterioration was determined to have arisen in this isolated area due to the proximity of the columns to the original boiler and the occasional flooding of the area. The heat and carbon dioxide/carbon monoxide from the boiler, plus the occasional presence of moisture, resulted in accelerated aging and carbonation of the concrete and corrosion of the steel reinforcing bars within the column.

WJE recommended partial demolition of the unsound concrete and developed a shoring plan to support the loads carried by the columns and to allow access for repairs. Construction drawings detailed partial-height repair of the columns, consisting of new steel reinforcing bar hoops and concrete encasement around the lower portion of the columns.
