Metallurgical Evaluation of Pipe Welds

Condensate Service Pipe Weld Cracking Failure Investigation | California, US

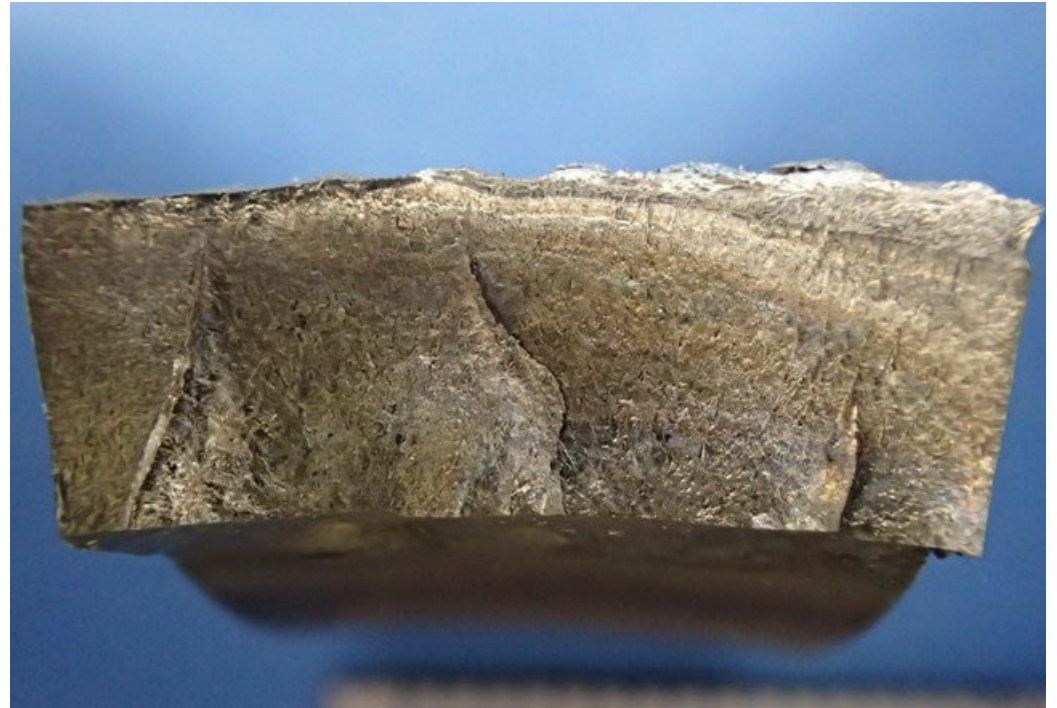
Laboratory observations indicated that the pipes did not exhibit significant corrosion or any indication of an environmental cracking mechanism. The fracture characteristics were consistent with a fatigue fracture mode. The chemical composition and microstructure of the components met the material requirements, with no anomalies detected that could have contributed to the fractures. Small cracks initiated on the inner-diameter surface at the root of the weld; this is typically a result of increased localized stress due to the geometry. WJE recommended a review of the pipe system and supports, including monitoring for vibration in the pipe circuit and review of inspection plans for similar piping circuits.
