The Case of the Rust-Stained Coated Snow Fences

By Leonard Phelps, PCS, Chemist and Associate Principal, and Kimberly Steiner, Chemist and Principal, WJE

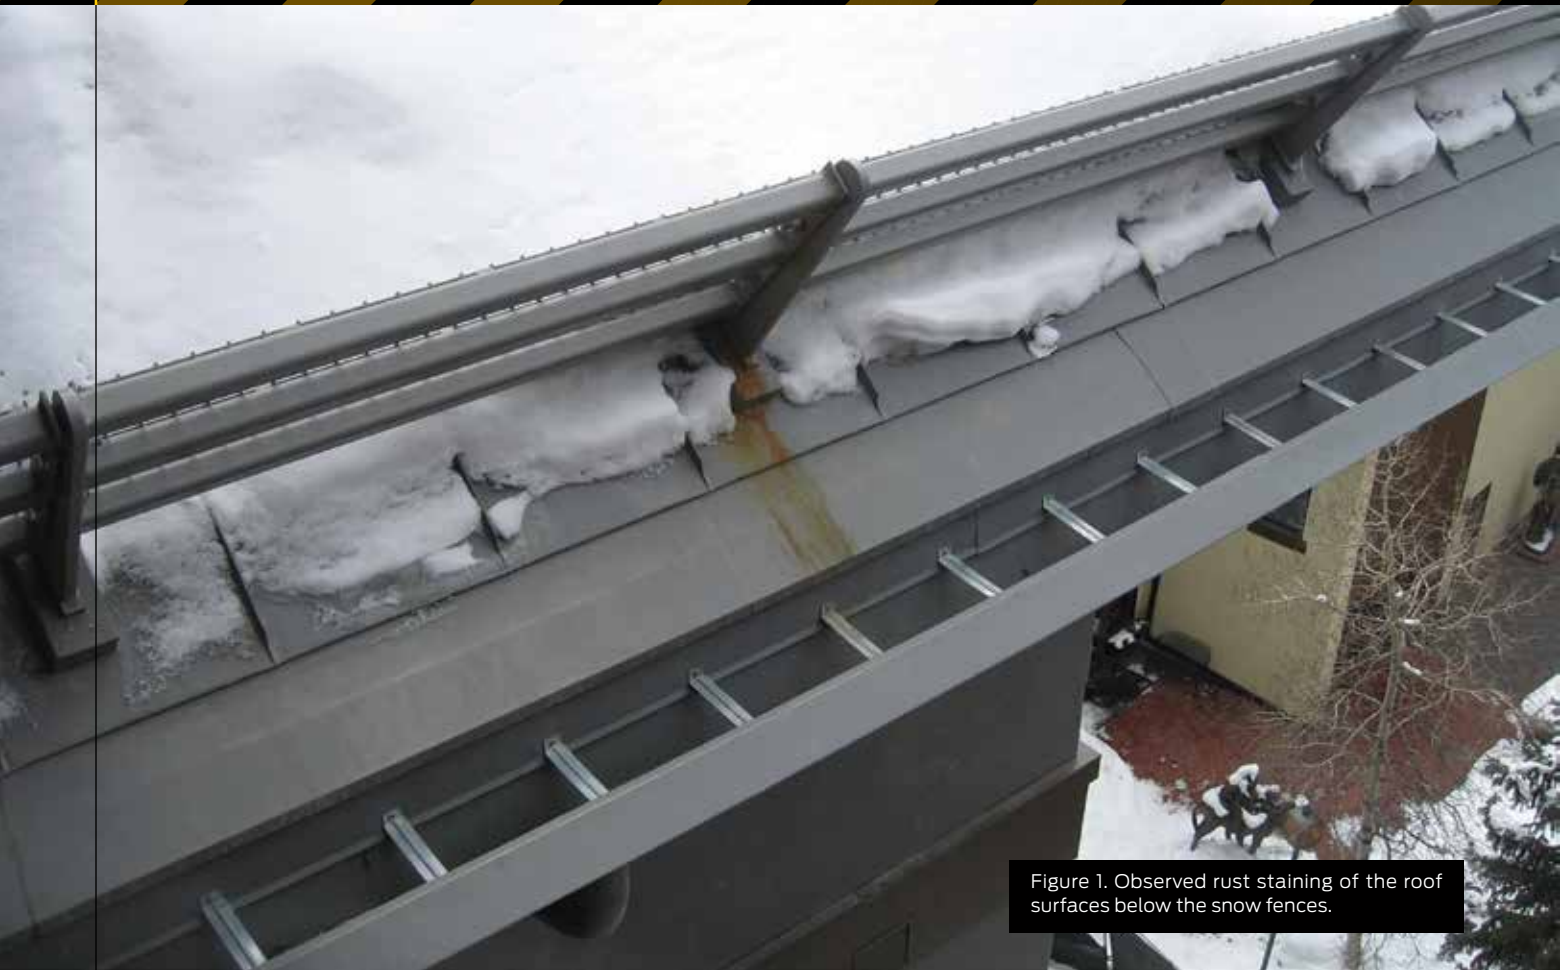
Figure 1. Observed rust staining of the roof surfaces below the snow fences.

fences, which are designed to restrict snow and ice from falling from roofs, were undergoing installation on a ski resort when rust staining of the roof surfaces below the snow fences was observed (see Figure 1). Studies were performed to determine the cause(s) of this premature coating/corrosion failure. Let's find out what went wrong.

As the original installation was nearing completion, poor adhesion of the coating system to the electroplated steel was discovered. Consequently, the snow fence panels were uninstalled, shot-blasted, and recoated with an EP/PU system. The refurbished panels were reinstalled, and before completion of the reinstallation, rust staining of the roof surfaces below the snow fences was observed at 45 locations.

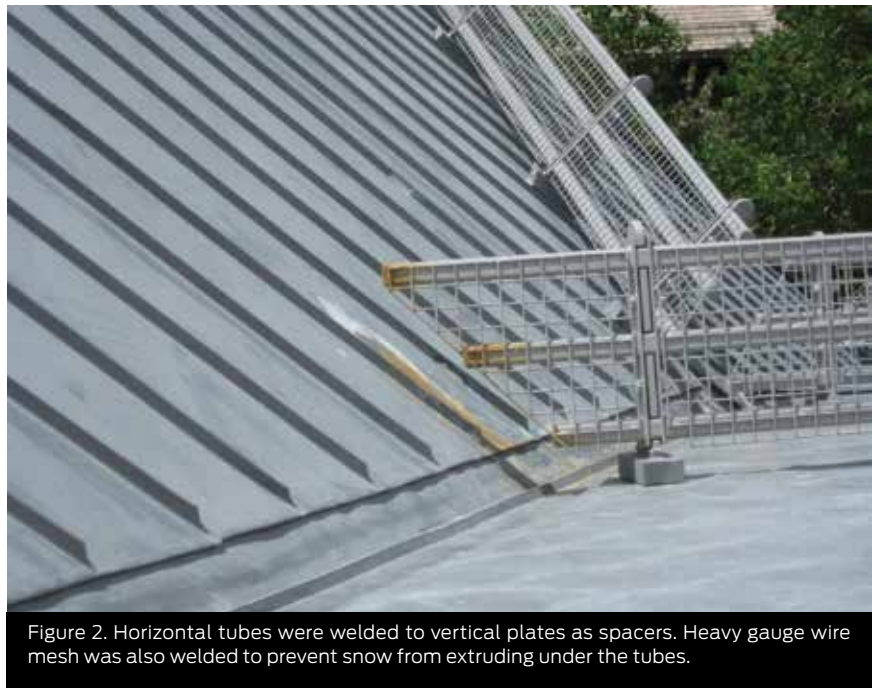
face of the panels to prevent snow from extruding under or between the horizontal tubes, which were spaced approximately 6 to 8 inches (15.2–20.3 cm) from the center of each rail (see Figure 2).

Figure 2. Horizontal tubes were welded to vertical plates as spacers. Heavy gauge wire mesh was also welded to prevent snow from extruding under the tubes.

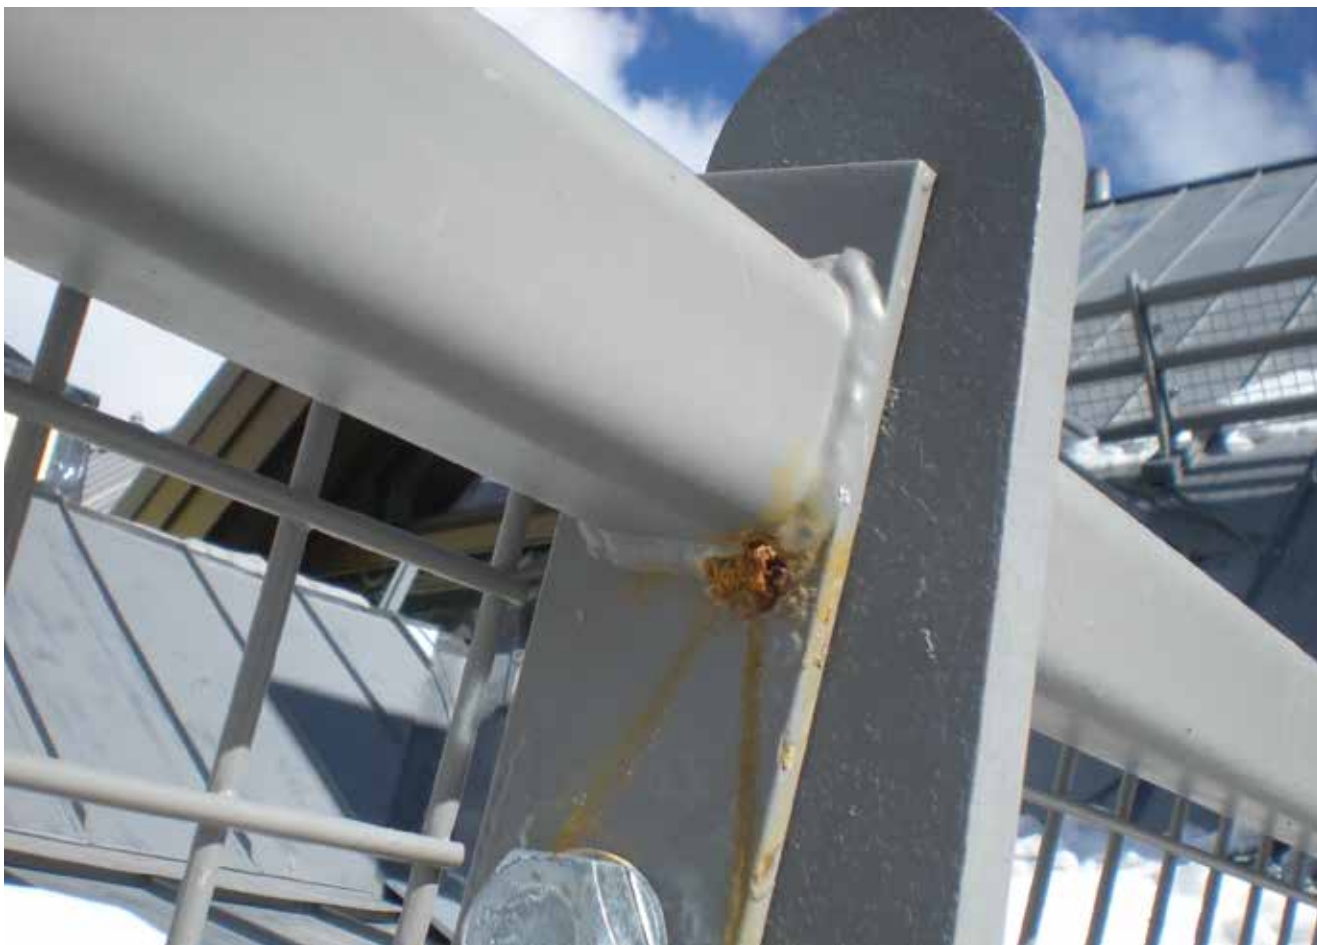
These fence panels exhibited minor coating damage — partially exposing the prime coat and steel substrate — due to handling, installation, dismantling, and transporting the samples to the laboratory. Typically, samples affected by rust stain appeared to originate from a roughly ¼-inch (0.6 cm) rust spot at the corner of a weld between the tube and endplate (see Figure 3).

The weld passes overlapped at the corners of the tube, which corresponds with where a ¼-inch spot of corrosion was typically observed on the samples.

Figure 3. Rust stain appeared to originate on most affected samples from a ¼-inch spot at the corner of the weld.

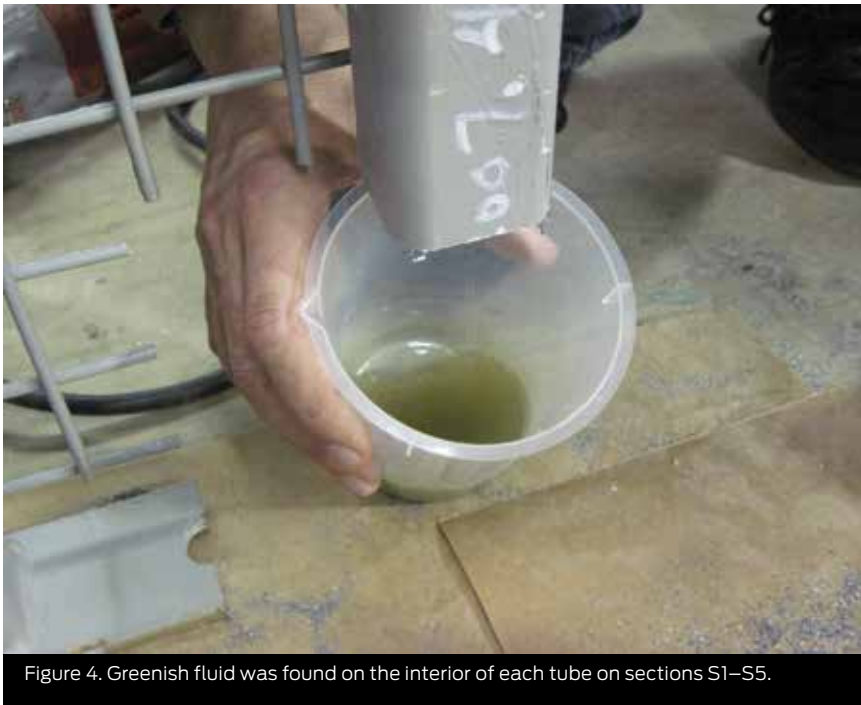
When the S1–S5 sections were cut open, between 15 and 80 mL (0.5–2.7 ounces) of greenish fluid was found on the interior of each tube (see Figure 4). These samples also exhibited rust staining on the exterior surfaces. To various degrees, corrosion was present on the interior of the tubes, but no appreciable section loss was observed. No fluid was observed when tubes of the S6 and S7 panels were opened.

Figure 4. Greenish fluid was found on the interior of each tube on sections S1–S5.

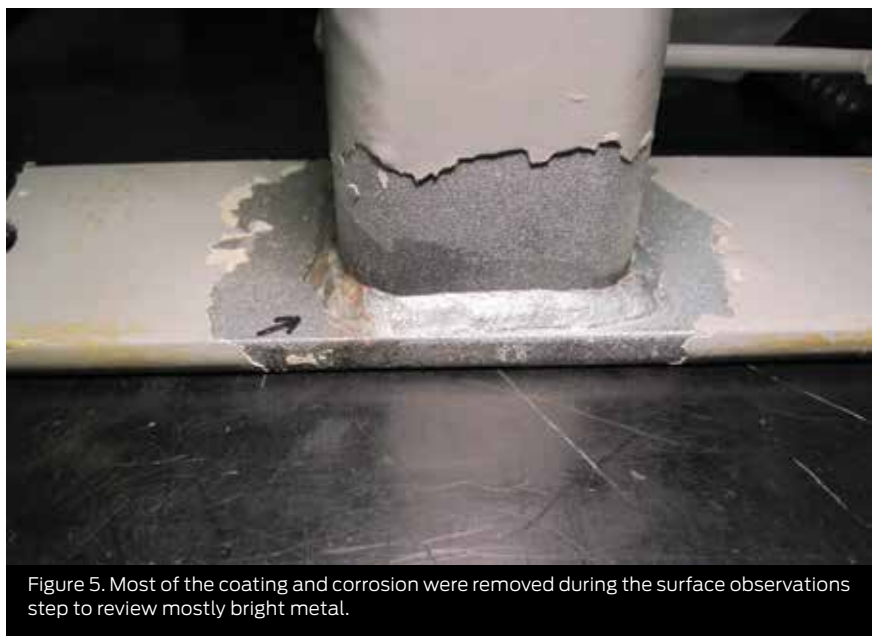
Two tube specimens were cut from the ends where each exhibited rust spots at the weld corners. The coating was removed from the weld area using a solvent-based stripper. Also removed was most of the corrosion to reveal mostly bright metal (see Figure 5), which suggested that the corrosion observed prior to stripping was rust stain on top of the coating.

Figure 5. Most of the coating and corrosion were removed during the surface observations step to review mostly bright metal.

Stripping the coating from the weld areas revealed mostly bright, peened metal beneath the coating system rather than any substantial rust. This indicates that the applied coating system is protecting the substrate.

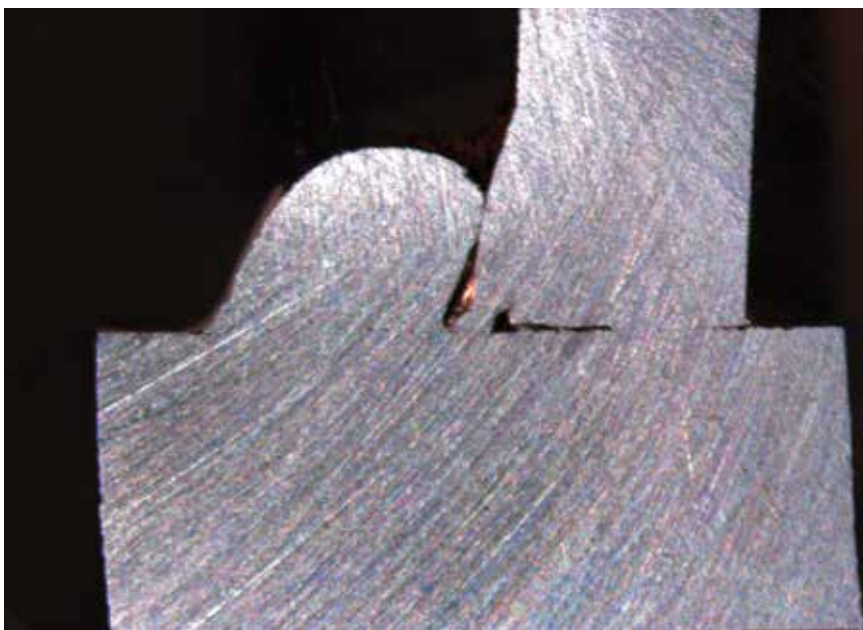
S1–S5 each had a rust spot at the weld corner and rust stain on adjacent coating. A transverse section was prepared from one sample for microscopical observation. Inadequate fusion was revealed between the tube wall and weld bead and in a crevice between the endplate and the tube (see Figure 6).

Figure 6. When a transverse section was prepared from a sample, inadequate fusion was revealed between the tube wall and the weld bead and between the endplate and tube.

welding process, a previously placed weld metal must remain molten between passes, or be sufficiently reheated, as the subsequent weld is placed. Without this, a lack of fusion between weld segments can create discontinuities in the welds, resulting in a path between the interior and exterior of the tube.

tube was connected to the exterior through gaps between the weld and tube caused by a lack of fusion during welding.

remedial drain holes may allow the chloride-laden fluids to drain, rinsing through drain holes may not adequately eliminate chloride and prevent future corrosion. The remedy would be to refurbish or make new fences with functional seal welds to prevent entry of chloride-laden fluids into the tubes in the first place. **CP**

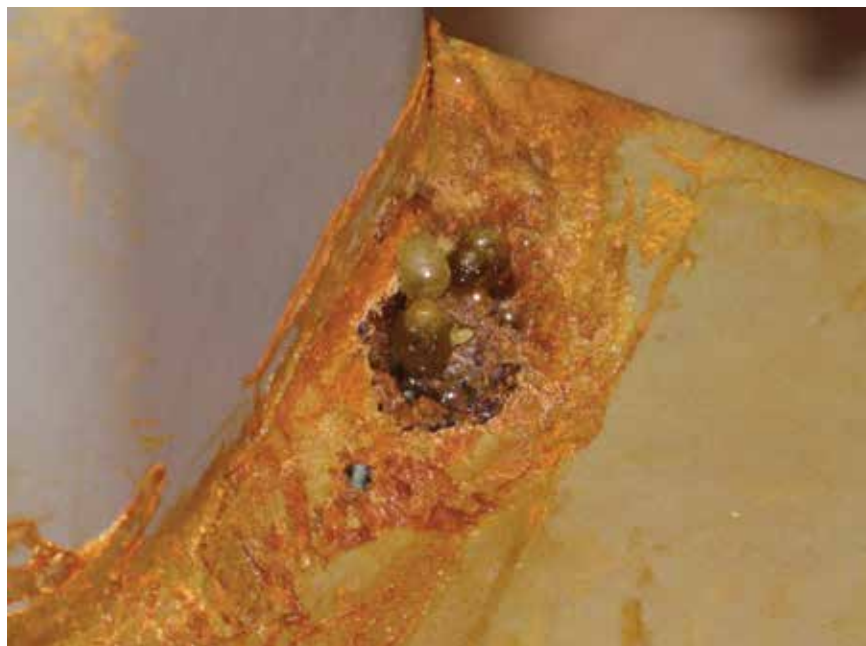
Prior to cutting, S6 and S7 were placed in a chamber under heat lamps for 72 hours, resulting in surface temperatures of 104–115 °F (40–46 °C). S8 welds indicated the formation of “new corrosion” made of several crusted bubbles with underlying fluid (see Figure 7).

Figure 7. Leakage testing indicated that "new corrosion" formed. This was made of crusted bubbles with underlying fluid.

out during service when the interior temperature and pressure increased due to exposure to sunlight, as demonstrated by the leakage testing. Trapped fluids flowed out, staining the fence and roof surfaces with chemicals and corrosion byproducts. This happened because electroplating and applied coatings are not designed to withstand the backside pressure from trapped chemical fluids and will eventually succumb to the effects of the trapped fluids leaking from the tubes until exhausted.
