## PROJECT PROFILE

# Roberts School Flats

Masonry Wall Consulting | Indianapolis, IN

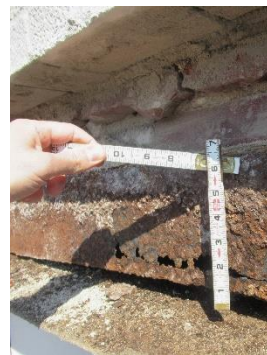
During the development and rehabilitation of the building, water leakage through the walls was observed. With less than six months left in the construction schedule, the urgency to investigate and repair the water leakage was high. Core Redevelopment engaged WJE to investigate the probable causes of water leakage and develop repair recommendations to mitigate the leakage.

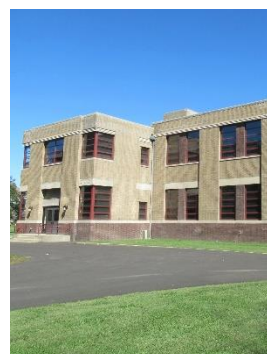
To investigate the source of water infiltration, WJE performed site visits to survey the locations of existing water damage on the replaced interior plaster finishes, observe inspection openings in the interior plaster, and observe an inspection opening at one second-floor window lintel on the south facade. Based on WJE's observations, the majority of water-damaged and stained areas on the interior finishes generally corresponded to severely corroded steel window lintel locations as well as a few isolated areas where severely deteriorated mortar joints existed in the brick masonry.

Based on WJE's observations, repair concepts were expedited and included replacement of the severely corroded steel lintels with new hot-dipped galvanized window lintels with through wall flashings incorporated into the repairs. In addition, WJE recommended replacing the deteriorated window perimeter sealants to mitigate possible sources of water infiltration at the window perimeters.
