**HEAVY MOVABLE STRUCTURES, INC.  
TWENTIETH BIENNIAL SYMPOSIUM**

**Kirkfield Lift Lock Incident - Control System  
Modifications and Temporary Control  
System**

R. McPherson, Y. Zheng  
WJE

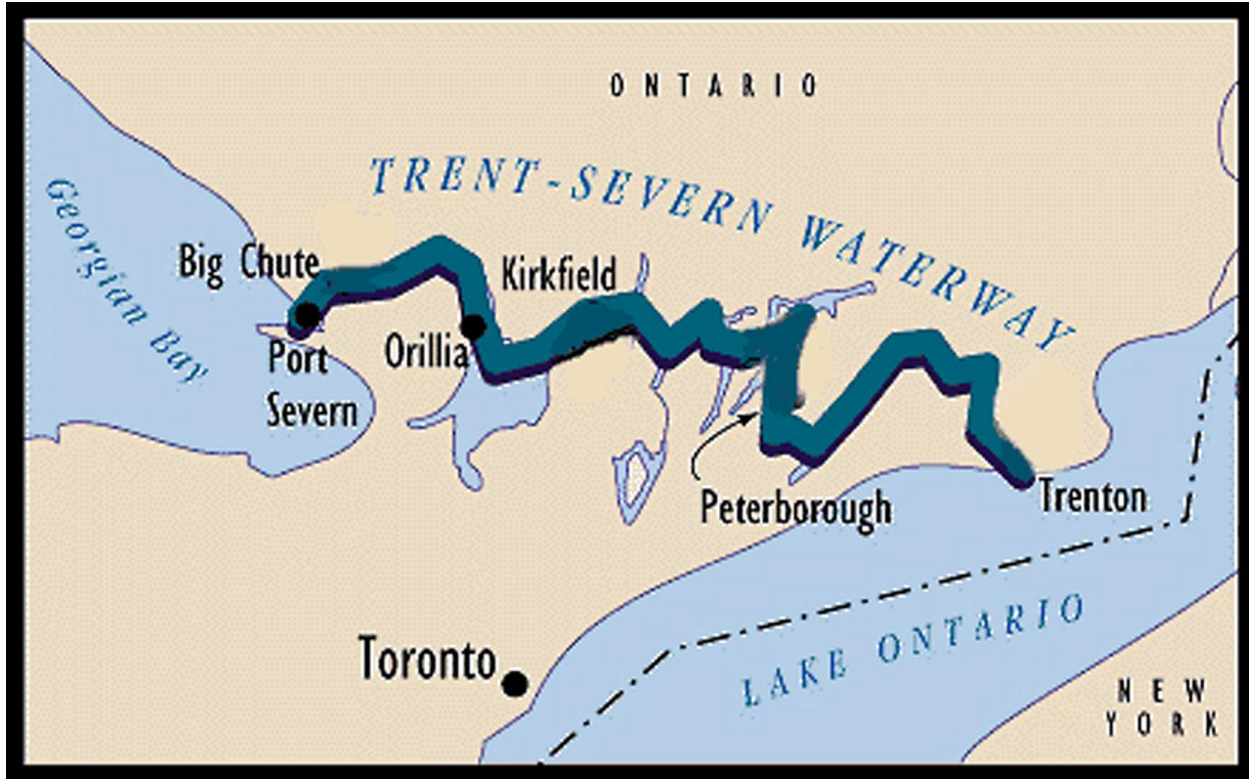
Figure 2 Trent-Severn Waterway map (Courtesy of Parks Canada)

The Kirkfield Lift Lock provides lockage to boats operating on the Trent-Severn Waterway. The Trent-Severn Waterway is a 240-mile-long canal connecting Lake Ontario to Georgian Bay on Lake Huron. Parks Canada is the agency responsible for both the canal and the Kirkfield lift lock.

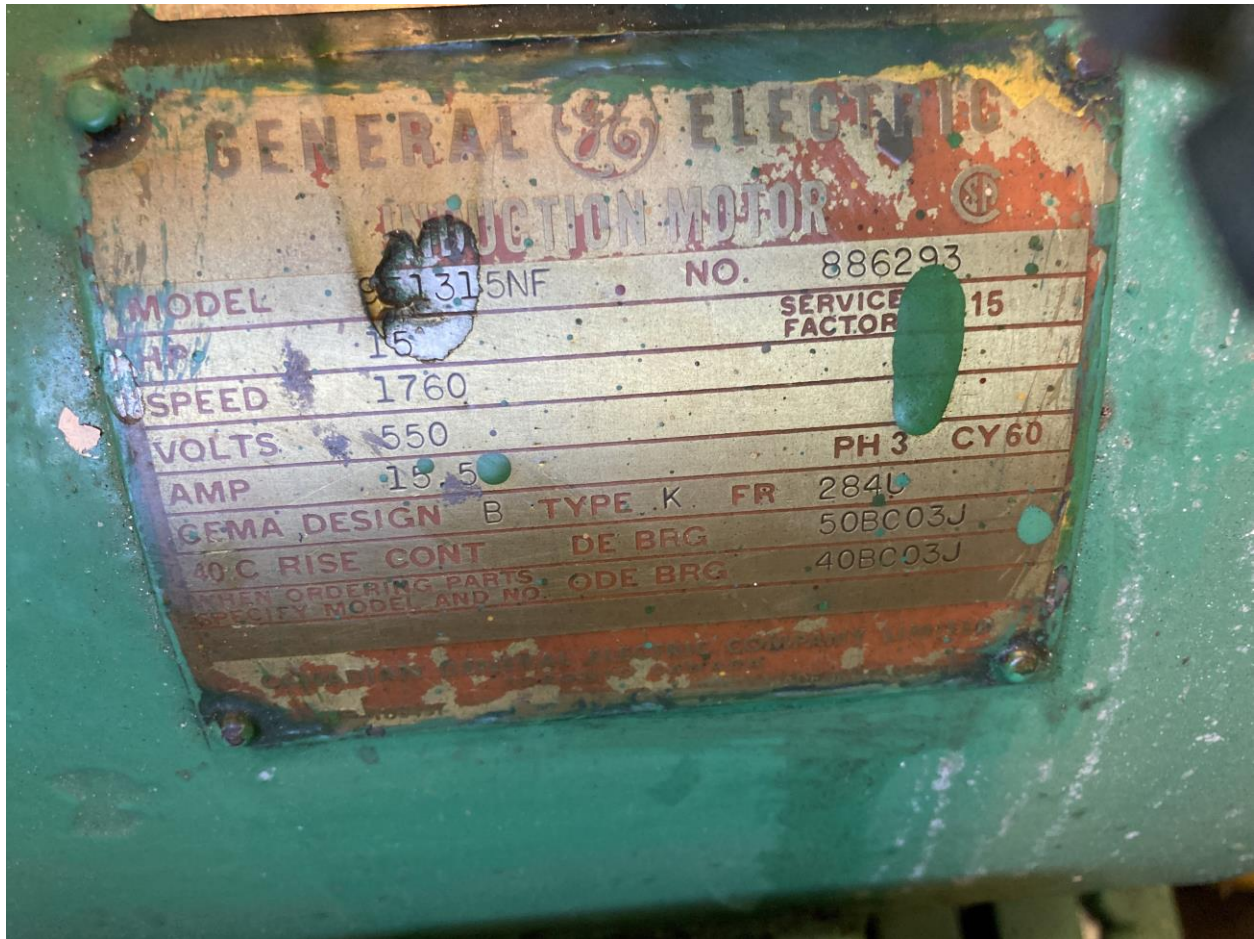
Figure 6 Water Hydraulic Pump Motor

3. Converting the water driven pumps to electrically driven motors and pumps.

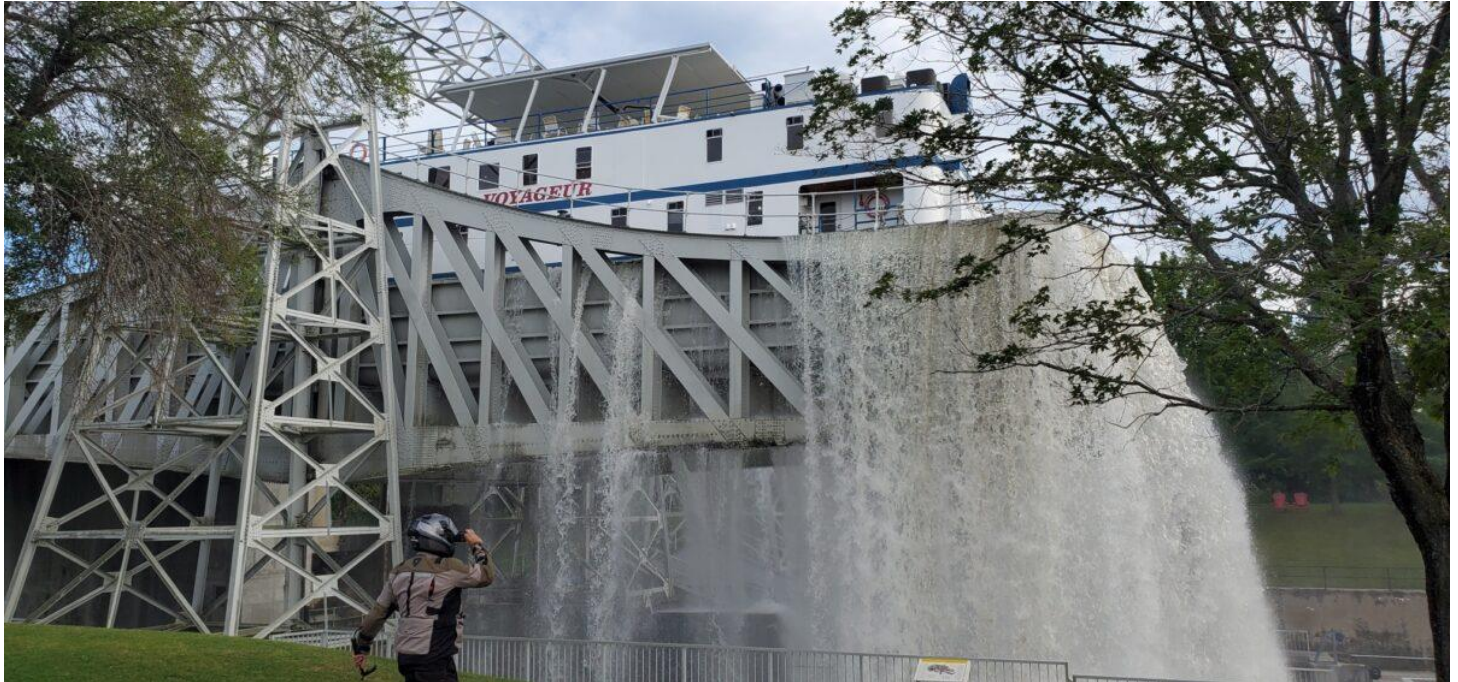
Figure 7 Incident at Kawartha Lift Lock September 3, 2022. (Courtesy of Kawartha 411)

At the time of the incident, the vessel was in the process of locking through from the north chamber to the upper reach. While the upper reach and chamber gates were open, the north chamber began moving in the absence of a controlled Lockmaster input. This incident resulted in damage to various components associated with the operation of the north chamber. In addition, during the recovery efforts, the lower level of the lift lock structure was flooded with several feet of water

The incident occurred near the end of the navigation season and Parks Canada staff operated the undamaged chamber of the Lock structure in a reduced capacity mode using electrically driven pumps and additional staff. This allowed stranded boats to return to their home ports. Once this was complete the lock was shut down for the season and planning began for its repair.

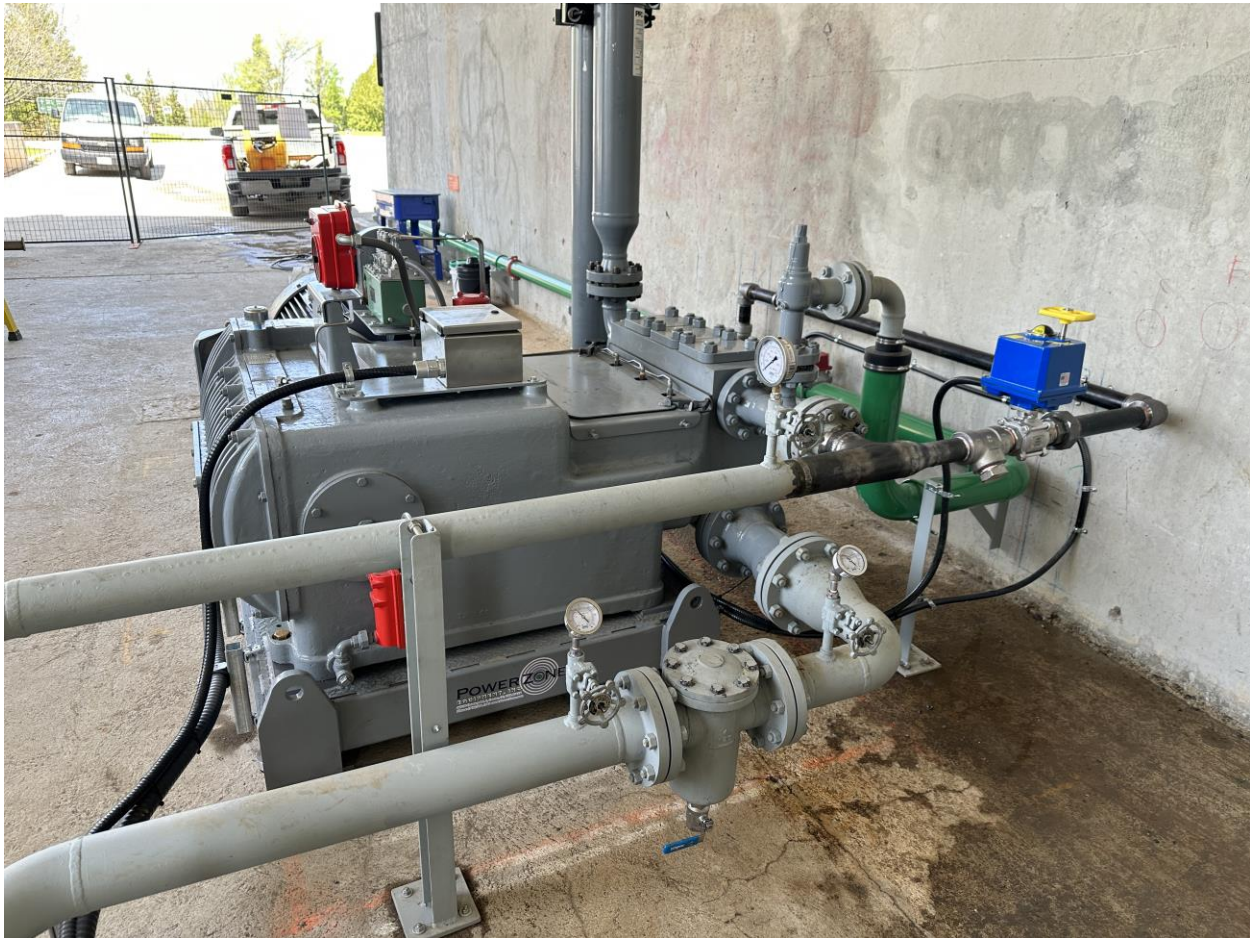
The lock was initially operated after the incident using small electrically driven pumps to provide water to move the single chamber. These pumps are used during normal operation to “trim out” the level of the locks and typically provide only small amounts of water. These pumps required over 4 hours to complete one operation of the locks. As such they were not suitable for other than incidental use. However, as the water hydraulic piping supported this type of operation already, larger water hydraulic pumps were considered as replacements to increase the speed of the chamber operation. After some study, it was decided that a temporary operating plan centering on providing a 150hp, electrically driven pump to support single chamber operation was the preferred option.

Figure 8 New 150 hp Pump for Single Chamber Operation

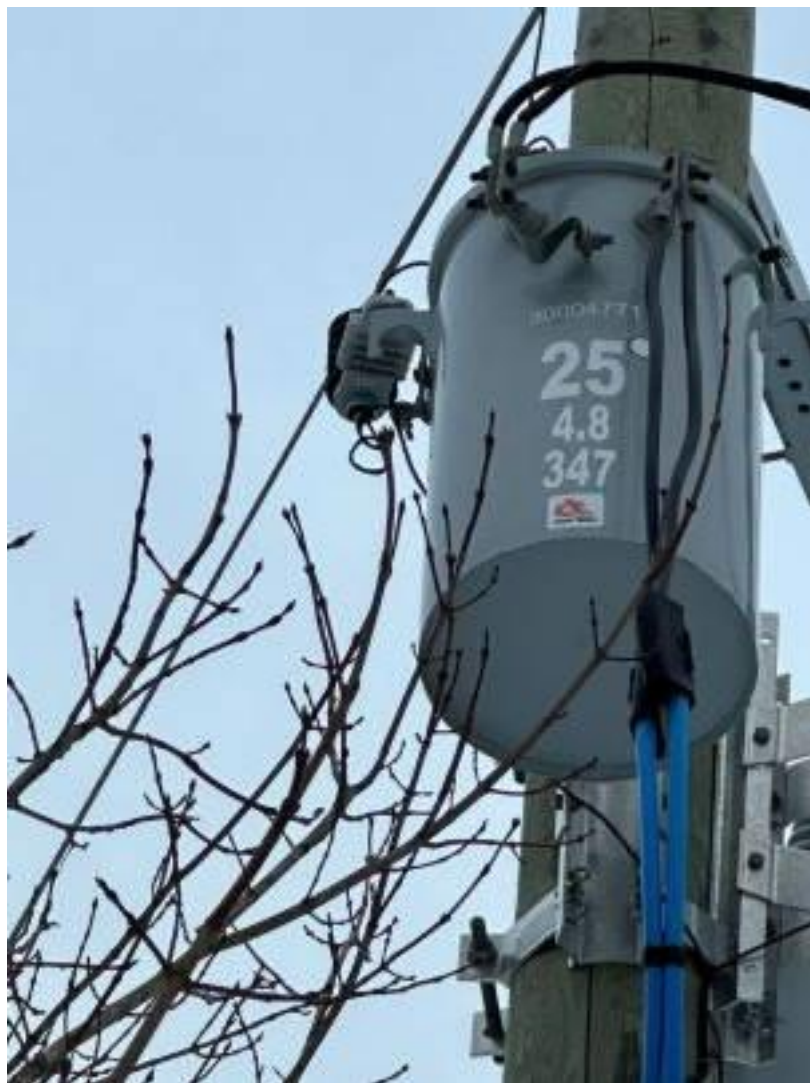
1. There was no available source of power on site that could support operation of the 150Hp pump.

Figure 9 Electric service transformer prior to upgrade which was inadequate to support 150hp operation.

Our electrical team was presented with a request to develop design documents necessary to install a standby generator which could support the electrical load imposed by the new 150hp pump. Other disciplines had held discussions and made plans based upon the standby generator prior to this request. However, our electrical staff felt that increasing the capabilities of the existing 3-phase utility service was

a better option and would probably reduce the risk of delays caused by procurement lead time of a suitable sized standby generator. Concerns were raised about whether the service upgrade request could be completed by the electric utility to meet the project deadline. We contacted the electric utility who felt they could meet the deadline if Parks Canada could provide documentation indicating the importance of the upgraded electric service. Our electrical staff and Parks Canada developed the documentation and submitted it the electric utility and followed up on a bi-weekly basis to ensure the utility had what they needed to meet the project deadline.

We also developed design documents for the upgraded electric service and its distribution to the new 150hp pump skid.

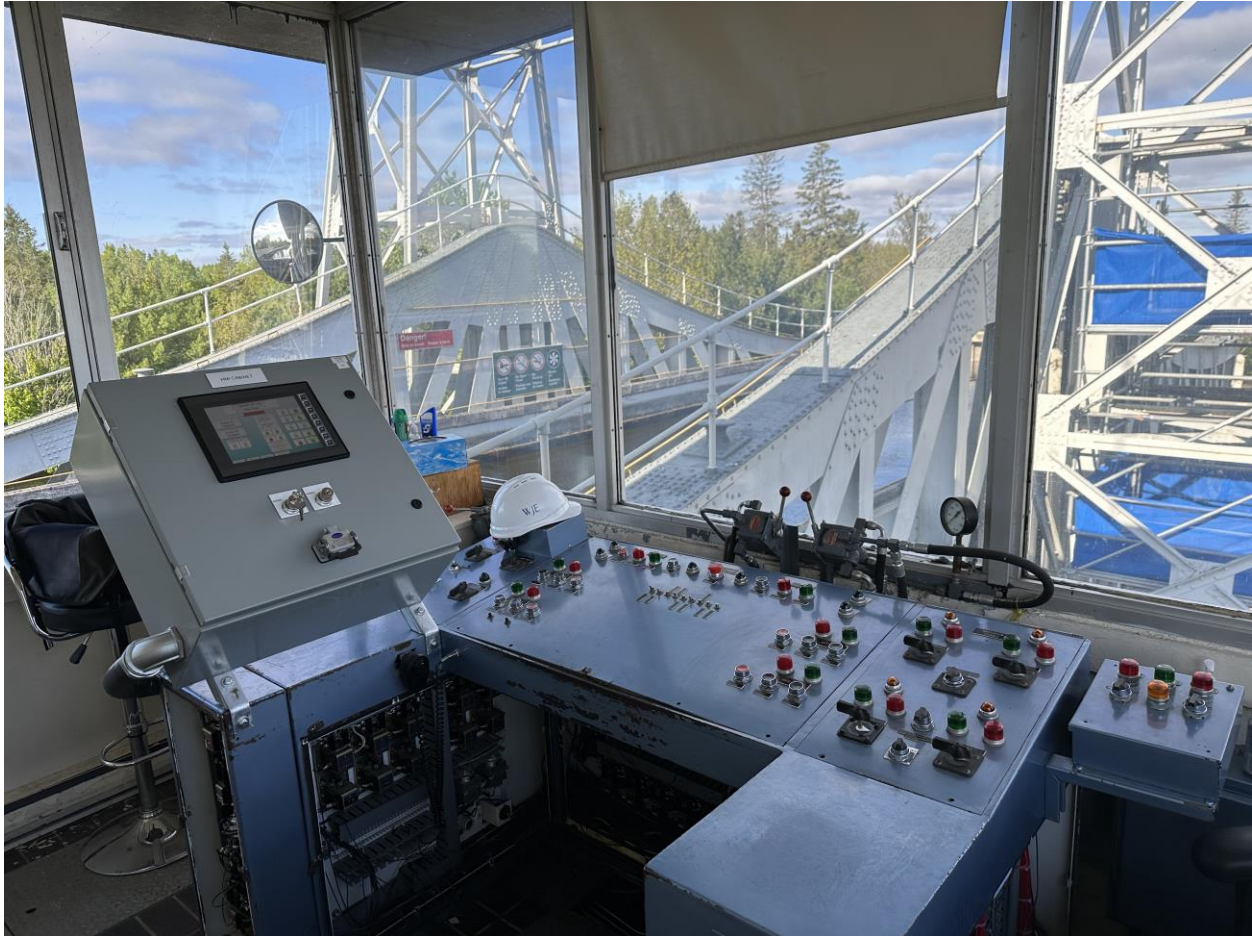
Based upon these criteria, we determined that an HMI based digital controller system operating in “piggyback” mode with the existing control system would be the most suitable solution. “Piggyback” mode in this instance means that the HMI based digital control system would be used to control the motion of the chamber and pick up all necessary limit switches and permissives from the control desk. The lock operators would use the existing control desk to perform the remaining control functions such as opening and closing the chamber gates.

Figure 10 Piggyback control system mounted on existing control desk.

The solution was expected to provide flexibility to accommodate changing system requirements and reduce overall wire counts. Quicker installation and return to normal operation were also benefits of this approach. Additionally, this solution met all the design criteria including limiting retraining.
