# FRANKLIN AVENUE BRIDGE

ANALYSIS, DESIGN, AND ACCELERATED BRIDGE CONSTRUCTION

by Dan Enser, HNTB Corporation; Arne Johnson and Dr. John Lawler, Wiss, Janney, Elstner Associates Inc.; and Paul Backer, Hennepin County

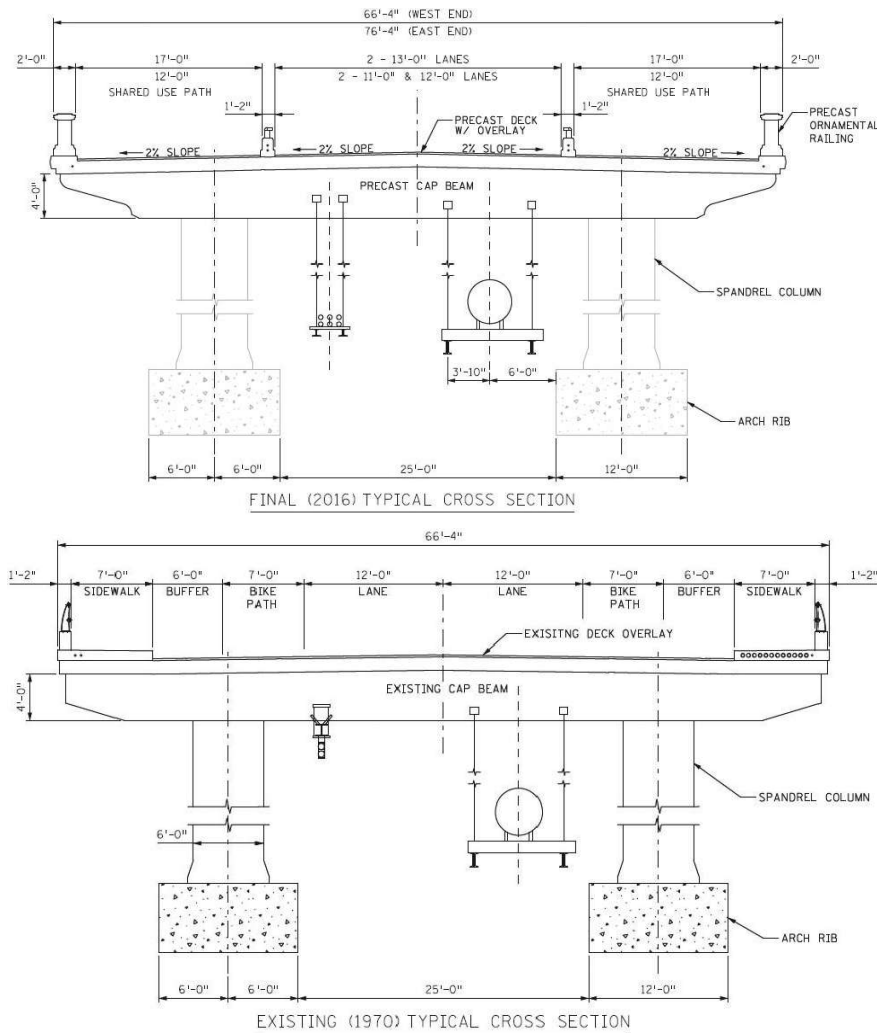
New (2016) typical cross section (top) and existing (1970) typical cross section (bottom). All Figures and Photos: HNTB Corporation.

- The bridge cross section was revised to accommodate a multimodal facility.
- Spandrel cap beams with historic scroll ends were used.
- Full-depth precast concrete deck panels were joined with ultra-high-performance concrete (UHPC).
- A premixed polyester polymer concrete (PPC) overlay was installed to protect the deck panels and construction joints from water ingress.
- Ornamental railing panels replicated the original 1923 design.

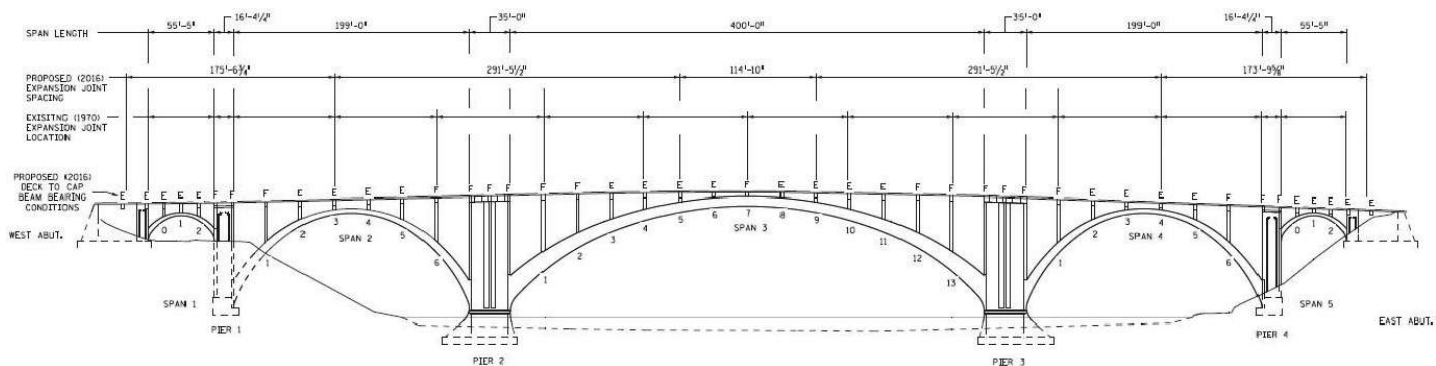
Bridge span layout with existing and proposed joint locations and deck-to-cap beam bearing conditions (E = expansion; F = fixed).

Reduction in the number of expansion joints was critical to extend the life of the structure. The greatest levels of degradation were found at the 15

existing expansion joints, which had allowed chloride-laden water direct access to the underlying, non-air-entrained original concrete elements. Reducing the number of expansion joints required a radical revision of the structural connectivity between the deck and cap beams. By allowing the deck to translate over the spandrel columns, the thermal forces within the spandrel columns and arch rib were greatly reduced. Releasing the connection between the deck and cap beams required a reliable, low-friction bearing assembly that would accommodate the translation associated with thermal movements.

strongly supported releasing the deck from the cap beams. While 15 of the existing expansion joints were removed, six were installed away from the substructure elements, reducing deterioration potential and extending bridge service life.

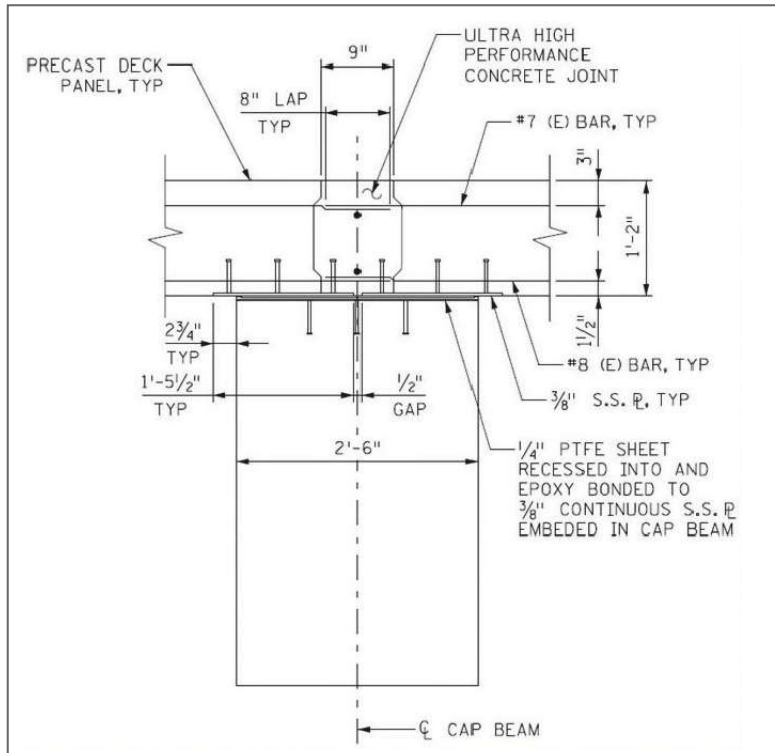
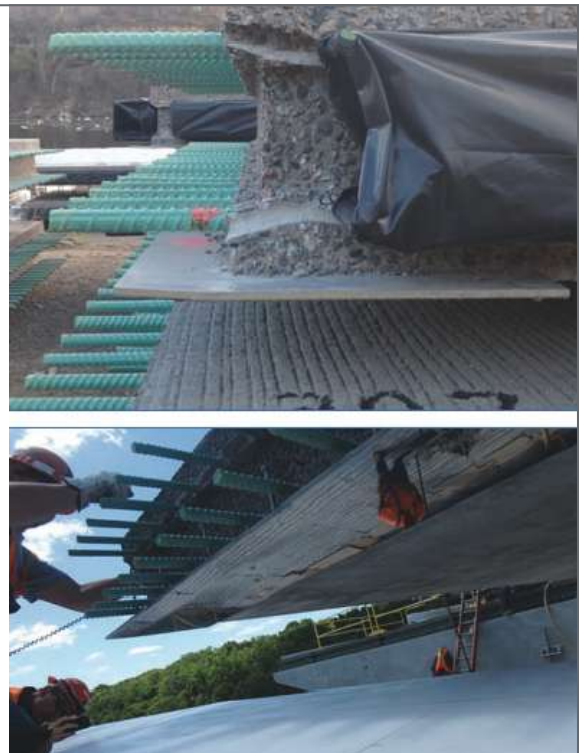
Typical sliding-plate joint and precast concrete deck panel joint.

A sliding-plate joint was developed, consisting of a polished stainless-steel plate embedded in the underside of the deck panels that slid on polytetrafluoroethylene (PTFE) bearing sheets recessed into stainless steel plates on top of the precast concrete cap beams. This innovative detail supported the deck loads and allowed the precast concrete deck panels to slide over the cap beams, offering minimal resistance to longitudinal translation.

Fortera building products manufacturing facility in Elk River, Minn., and the cap beams over piers were fabricated by the contractor. To facilitate the ABC approach, embeds to support temporary works and cap beam connectivity to spandrel columns were incorporated into the design. Cap beams at sliding and expansion joints had stainless-steel plates embedded in the top of the cap beam, with a recess of 1/8 in. for the PTFE sheets.

Innovative materials made the Franklin Avenue Bridge project feasible. UHPC allowed the deck to be continuous over the supporting cap beams with narrow joints between deck panels. The new cap beams, at 2 ft 6 in. wide, would not have accommodated traditional reinforcement bar splices without significant additional falsework. The rapid strength gain of UHPC allowed the contractor to move swiftly to the next erection step. The physical properties of UHPC, together with its material characteristics, provided a perfect application for this material. It is the first project in Minnesota to use UHPC to join deck panels and the second largest application of UHPC in the United States.

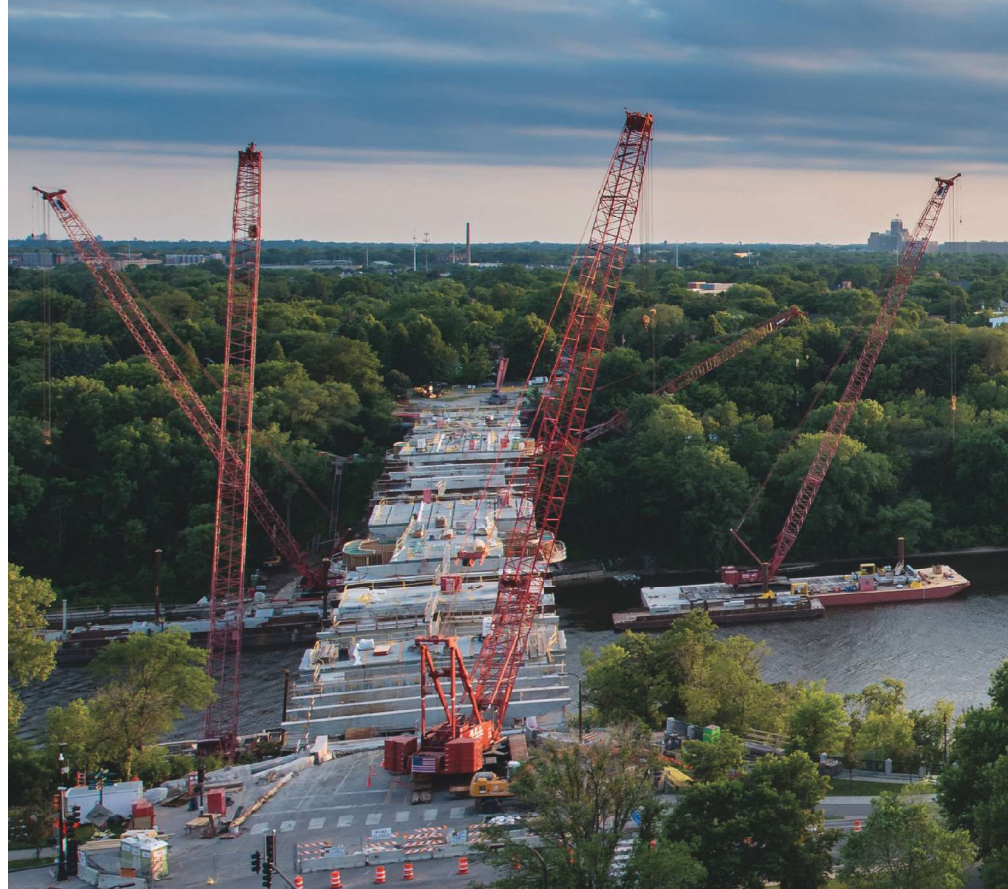
Accelerated bridge construction (ABC) operation.

The bridge was closed on May 8, 2016, and on-site construction began. The use of ABC together with PBES allowed for an accelerated construction time frame and minimized disruption to the public. On September 1, 2016, after 116 days, the third rehabilitation of the iconic Franklin Avenue Bridge was complete and the bridge was opened to traffic, to the great appreciation of the public.

ABC task	Task completion (days after closure)
Existing deck removal	Day 36
Existing cap beam removal	Day 39
Precast concrete cap beam erection	Day 43
Precast concrete deck panel erection	Day 51
UHPC placement at deck panel joints	Day 79
Ornamental steel railing post placement (north sidewalk)	Day 101
Precast concrete ornamental rail panel installation and pilaster casting (north sidewalk)	Day 113
PPC overlay placement	Day 114
<b>Bridge opened to traffic</b>	<b>Day 116</b>
