STRUCTURE

OCTOBER 2024

Deflection and Cracking of Two-Way, Conventionally Reinforced Concrete Slabs

A measured response based on a full understanding of cracking and deflection can help engineers and owners avoid unnecessary panic and intervention.

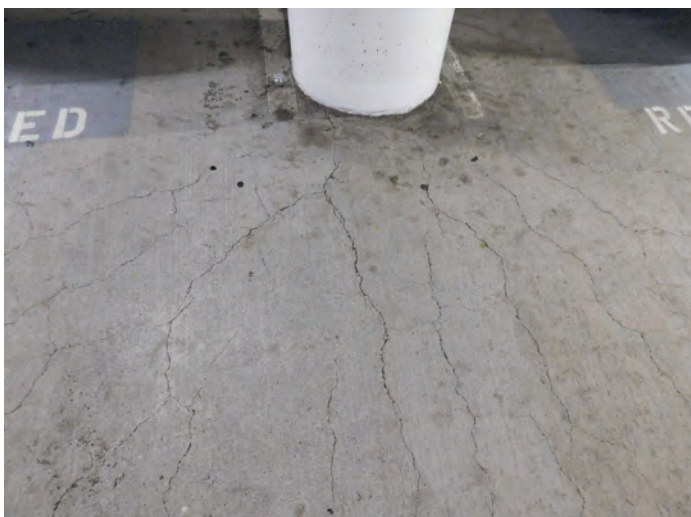
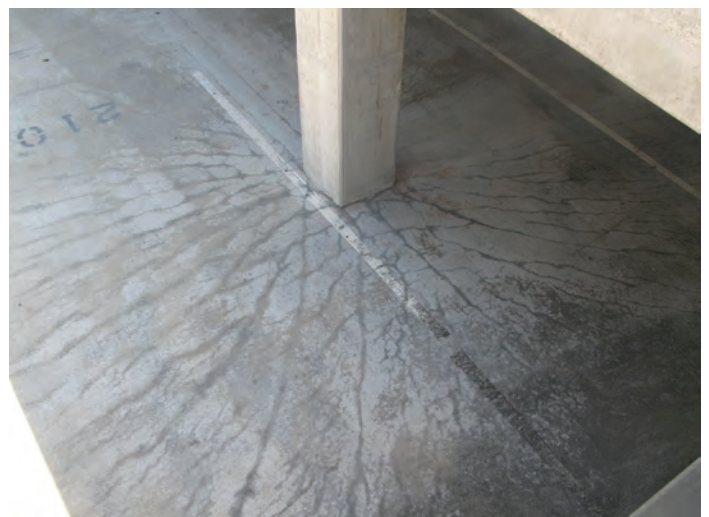
Fig. 1. Radial cracking appears in the two-way floor slabs of a garage built circa 1985 (left) and a garage built circa 2008 (right). Both structures are still in service.

It is critical to recognize that both radial cracking, where cracks radiate outward from the columns, and spiderweb cracking, where the cracking looks like a spiderweb on the surface of the slab with both radial cracks and cracks interconnecting the radial cracks, are extremely common on the top surface of two-way slabs. Figure 1 shows typical radial cracking in two-way slabs; Figure 2 shows typical spiderweb cracking in two-way slabs. Such cracking typically goes unnoticed, and the structures continue to function as intended.

As described in the September issue of *STRUCTURE*, radial and spiderweb crack patterns are characteristic of flexural behavior. However, it is not uncommon for engineers investigating existing two-way slabs to conflate the radial and spiderweb cracks with punching

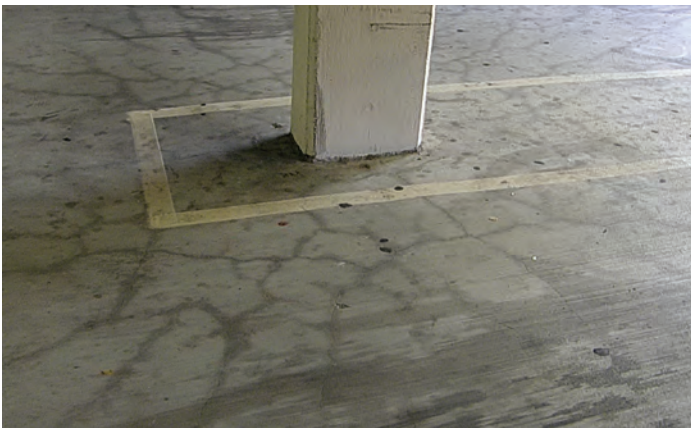
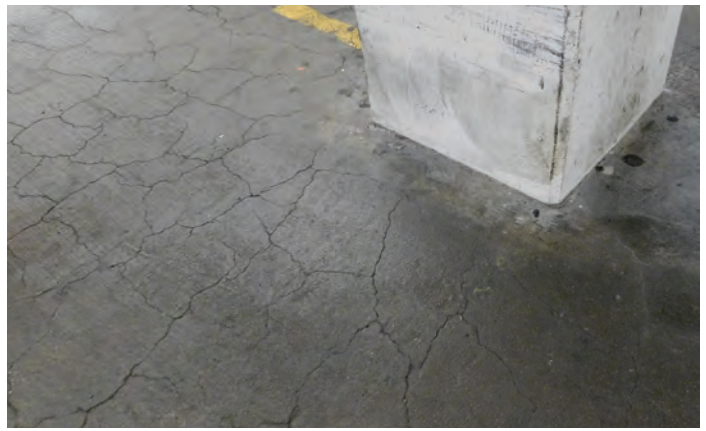
Fig. 2. Spiderweb cracking appears in the two-way slabs of a garage built circa 1991 (left) and a garage built circa 1987 (right). Both structures continue to function without issue more than three decades after they were built.

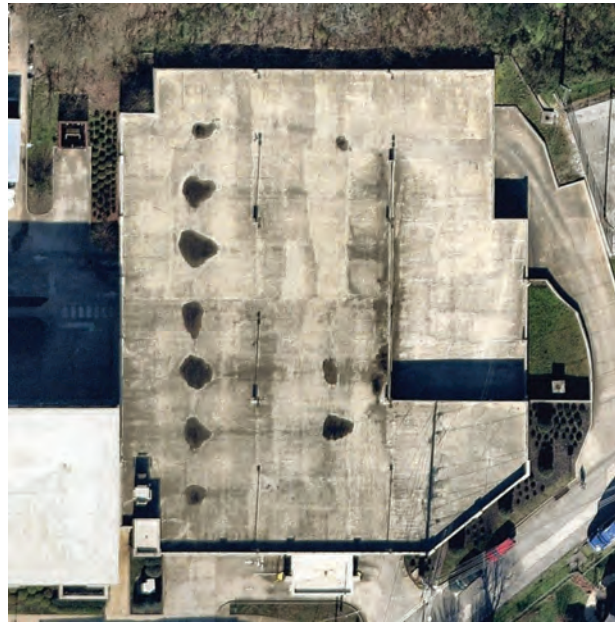
Fig. 3. Mid-bay puddles in a parking structure roof slab are due to the unavoidable deflection of the roof slab between columns. Photo courtesy of www.nearmap.com.

Even if camber is installed, it cannot solve all deflection issues. Engineers, architects, and owners often do not understand what camber can and cannot do. A slab that is exposed to water and that was constructed without an overall slope-to-drain will develop mid-bay puddles at the low points of the deflected shape, cambered or not. If excessive camber is specified and slab deflection does not overcome the camber, the slab will slope towards the column lines, and water will collect there. If only moderate or minimal camber is specified and slab deflection is greater than the camber, the slab will still tend to slope towards the centers of the bays, and water will collect there. Moreover, because deflection is time- and load-sensitive, slab drainage characteristics change over time. The only way to reliably avoid puddles in a two-way slab that is exposed to water is to provide sufficient overall slope in the slab that exceeds the local slope caused by deflection so that water will drain to one edge or point, or to install drains at the low point of every bay. Figure 3 shows an aerial photo of a parking structure; the presence of the puddles does not indicate that the slab is performing poorly; rather, the puddles indicate that drains should have been designed and installed in the middle of every bay but were not. Similarly, if designers do not want the water in those puddles draining through the slab, a traffic coating should be specified. The fact that water will travel through the inevitable cracks in a concrete slab should not be taken as convincing evidence that the slab is performing poorly.

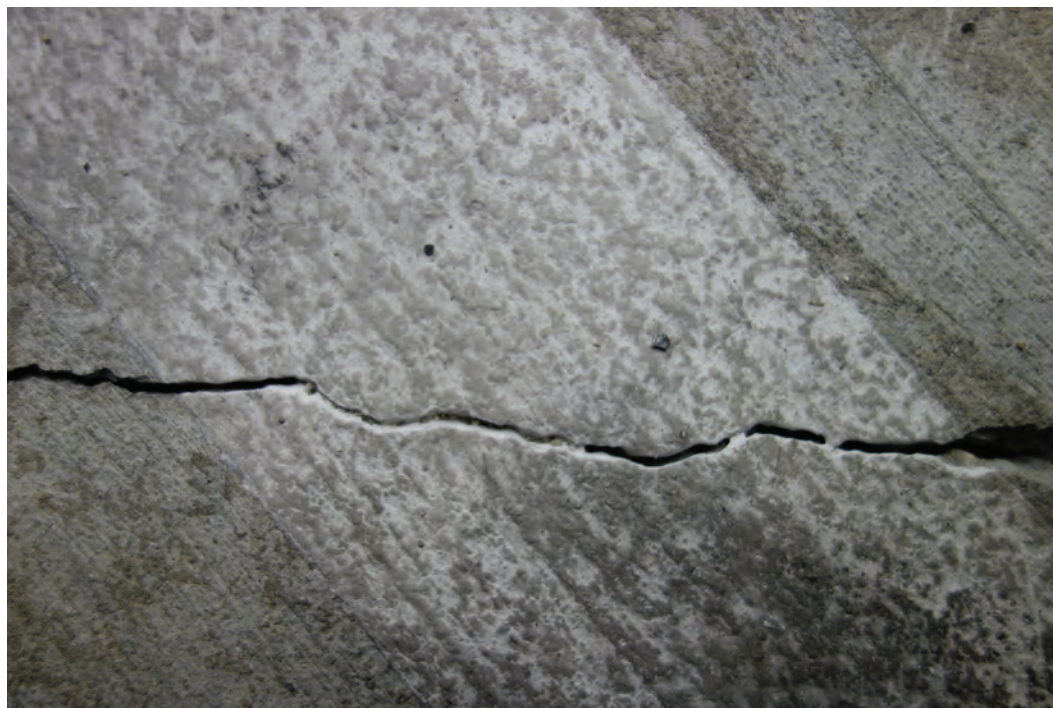
Fig. 4. Paint from this parking stall stripe is present within and spanning across the crack, indicating that the crack was present at the time the paint was installed and that the crack has not moved substantively since.

soot, dirt, patching compound, prior repairs, and carpet glue within a crack all indicate that the crack was present at the time the material was applied over or accumulated in the crack. Figure 4 shows an example of paint within a crack that can be used to estimate the age of the crack.

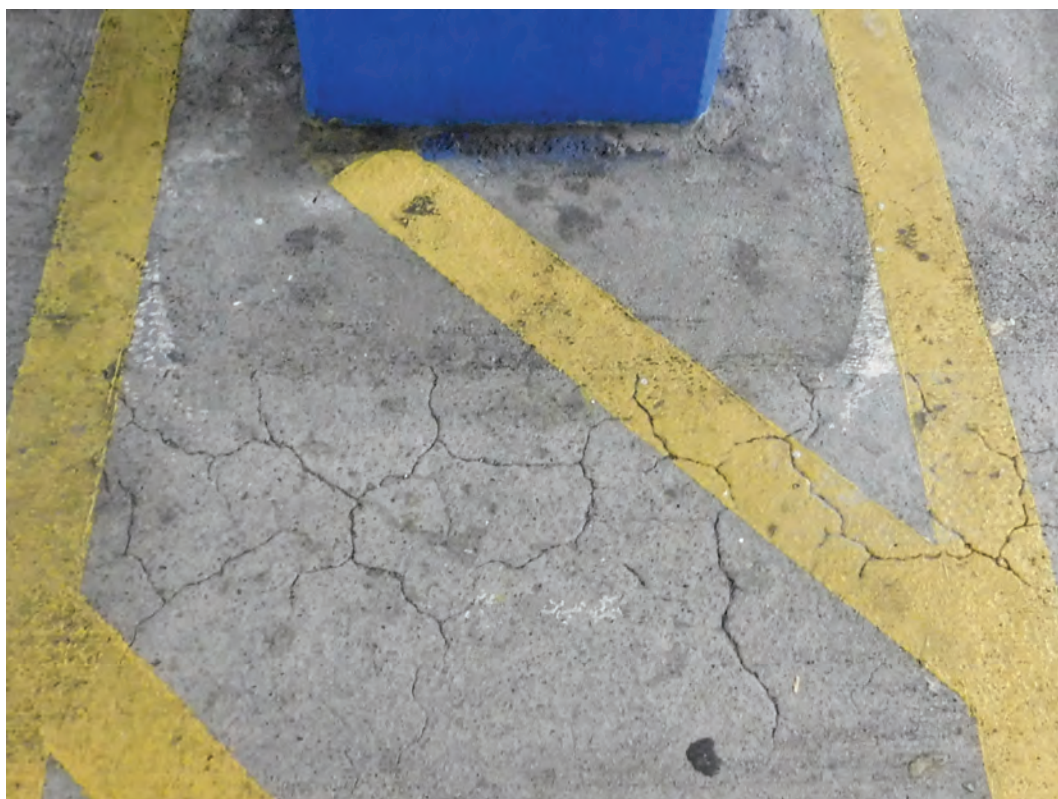
Fig. 5. This photo shows a swath of slab that has been bead-blasted or otherwise ground down to remove a curved white line; the mechanical removal of the line resulted in the cracks that were already present in the slab becoming noticeable due rounding of their edges.

Similarly, take care not to overestimate the width of cracks, particularly when the edges of the cracks are rounded or raveled. It is common for the edges of cracks to spall and become rounded over time when subjected to vehicular and even pedestrian traffic. Surface preparation like bead-blasting prior to installation of finishes, or to remove finishes, can also make a dramatic difference in the appearance of cracks (Fig. 5). Since the purpose of measuring crack widths is generally to understand their structural relevance, it is the crack width at-depth that is most relevant, not the crack width at the surface.
