**HEAVY MOVABLE STRUCTURES, INC.
TWENTIETH BIENNIAL SYMPOSIUM**

**Rehabilitation of the Route 250 Lift Bridge
Fairport, New York**

Robert J. Tosolt, P.E.
Wiss, Janney, Elstner
Associates, Inc.

Paul Mongiovi, P.E.
Colliers Engineering and
Design

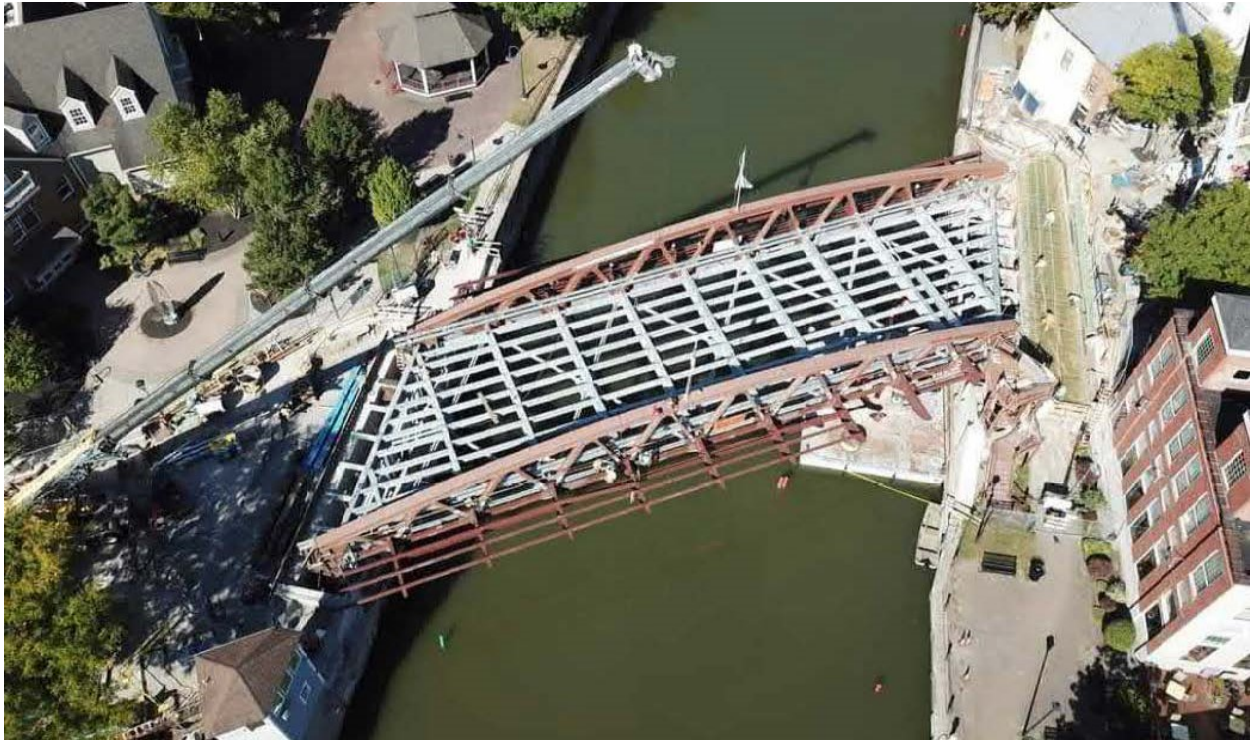
Figure 3 – Aerial View of framing during rehabilitation illustrating skew geometry.

In addition to these site constraints, the bridge features complex geometry as it has a 32° skew, 4% longitudinal grade, and is asymmetric. As a result of the site and geometry complexities, the rehabilitation was completed with the bridge in the raised position and temporarily supported for a majority of the project.

This added complexities as a significant portion of the existing structural steel required replacement. Only the top chord, diagonals, four lifting posts, and two lifting beams were retained and repaired; all other members (floor beams, stringers, bottom chords, lateral bracing, steel roadway and sidewalk decks, sidewalk brackets, sidewalk floorbeams, machinery supports, and end lifting frames) were fully replaced with galvanized steel. Temporary post-tensioned tie rods were installed between the end posts of the truss during construction to facilitate the staged replacement of the bottom chord of the truss. This ensured the bottom chord could be replaced under near no-load conditions.

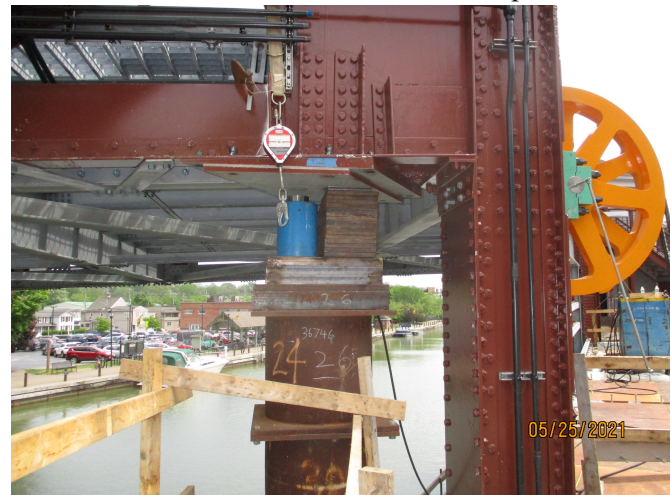
Figure 4 –Jacking Column for Span Support

The project scope encompassed the complete replacement of the operating and support systems as well as a comprehensive rehabilitation of the lift span superstructure which items would render the lift span inoperable for considerable time. The contract documents required that navigation not be impeded by the construction work and provided the option to either complete the work with the lift span in the raised position or to remove the lift span. The documents also specified that the lift span be weighed at different times during construction with load cells to gain precise weight measurements so that the new counterweights could be properly sized. The contractor opted to support the lift span in the raised position and provided temporary support frames that were under each end of the lift span. To address the unique challenges with achieving the required span geometry considering the high skew and change in elevation due to the four percent grade, the temporary support frames incorporated jacking points at each end post. The jacking points allowed independent adjustment at each corner to obtain the proper longitudinal grade and transverse slope and also facilitated installation of load cells for span weighing.

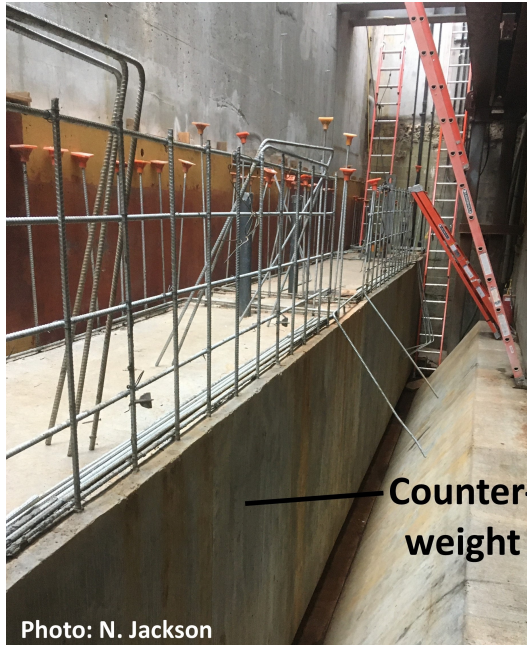
Figure 5 –New Counterweight at Interim Stage of Construction

New counterweights were required to offset the weight of the rehabilitated lift span. The design maintained the use of concrete counterweights, which suited the damp environment in the counterweight pits. The overall counterweight dimensions were dictated by the limited space in the counterweight pits and closely matched the existing dimensions; the counterweights are closely bounded on all sides and there is minimal clearance for overrun on the top or bottom due to the machinery beams above and the pit floor below. As a testament to the close tolerances, at the North counterweight pit, a pre-existing problem had been identified with the counterweight rubbing the pit side wall during operation. One goal of the rehabilitation was to eliminate this interference. In order to achieve the necessary counterweight density to offset the new span weight while maintaining the required clearances, steel ballast in the form of rolled steel beams and steel ballast plate were embedded in the concrete at strategic locations to provide additional weight and provide for transverse weight distribution. The new counterweights were formed up and poured in place in each counterweight pit. The contract documents specified two separate

concrete pours for the counterweights. Following the first pour, the lift span and partially completed counterweights were weighed and adjustments to the amount of embedded steel plate ballast in the second pour were made to achieve the balance condition.

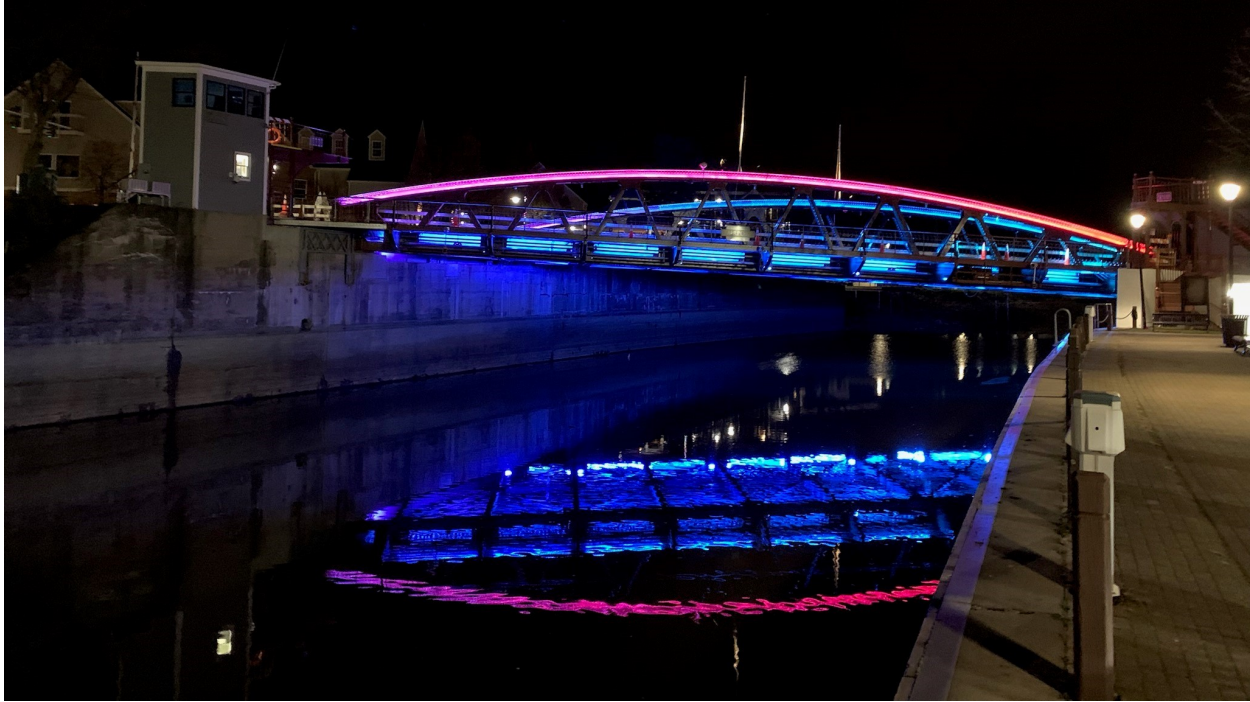
Figure 9 – Fairport Lift Bridge. Iconic lighting.

Architectural bridge lighting was added to the project in conjunction with New York State's "Re-Imagine the Canals" program. The iconic lighting include illuminating the truss chords and diagonals above the roadway along with under-bridge lighting. Special attention and detailing was required to hide the fixtures in the truss top chord gusset plates and to provide glare shields for the under bridge lighting. Additionally, the weight of the lighting and supports had to be factored into the bridge balance calculations to meet the project balance requirements. The lights are programmable high-efficiency LED luminaires that can be operated remotely and can change color to observe holidays or other theme.

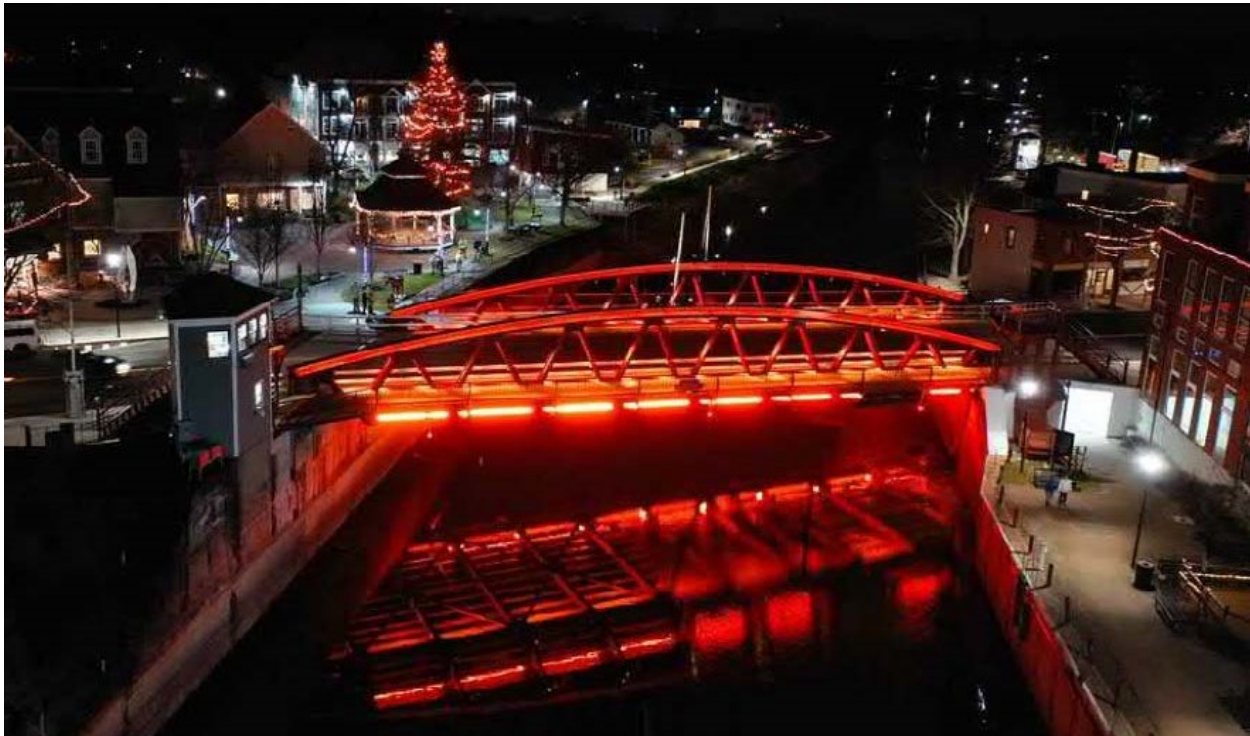
Figure 10 – Fairport Lift Bridge. Iconic lighting display for holiday.
