Trimont Condominiums

Facade Condition Assessment | Pittsburgh, PA

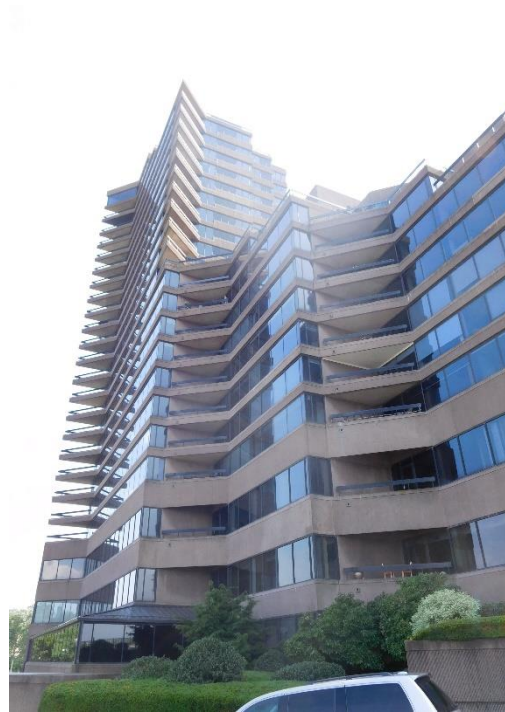
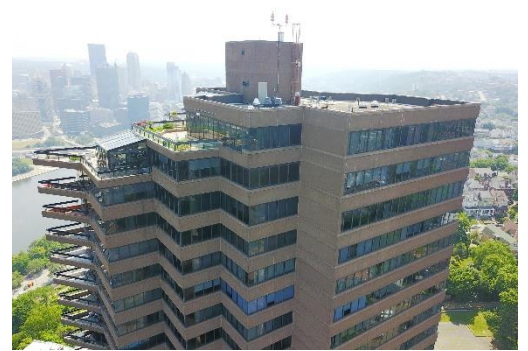
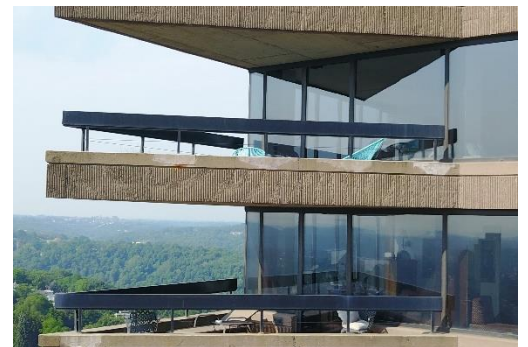
Concrete spalls throughout the facade appeared to be directly related to corrosion of the embedded reinforcement. The incipient spalls observed at many locations presented a risk of falling debris to pedestrian and roof areas below. Field observations of reinforcement cover dimensions revealed that reinforcement bars were located near the exterior surface of the concrete in numerous locations. The corrosion of the embedded steel reinforcement did not appear to be caused by chloride admixtures within the concrete, but rather by carbonation of the concrete from natural atmospheric exposure of the building.

Recommendations were provided to conduct a more detailed examination in preparation of developing a comprehensive repair program.
