# Assessment and Repair of Historic Plaster Systems

## (Part 2)

### Michael J. Howlett Building

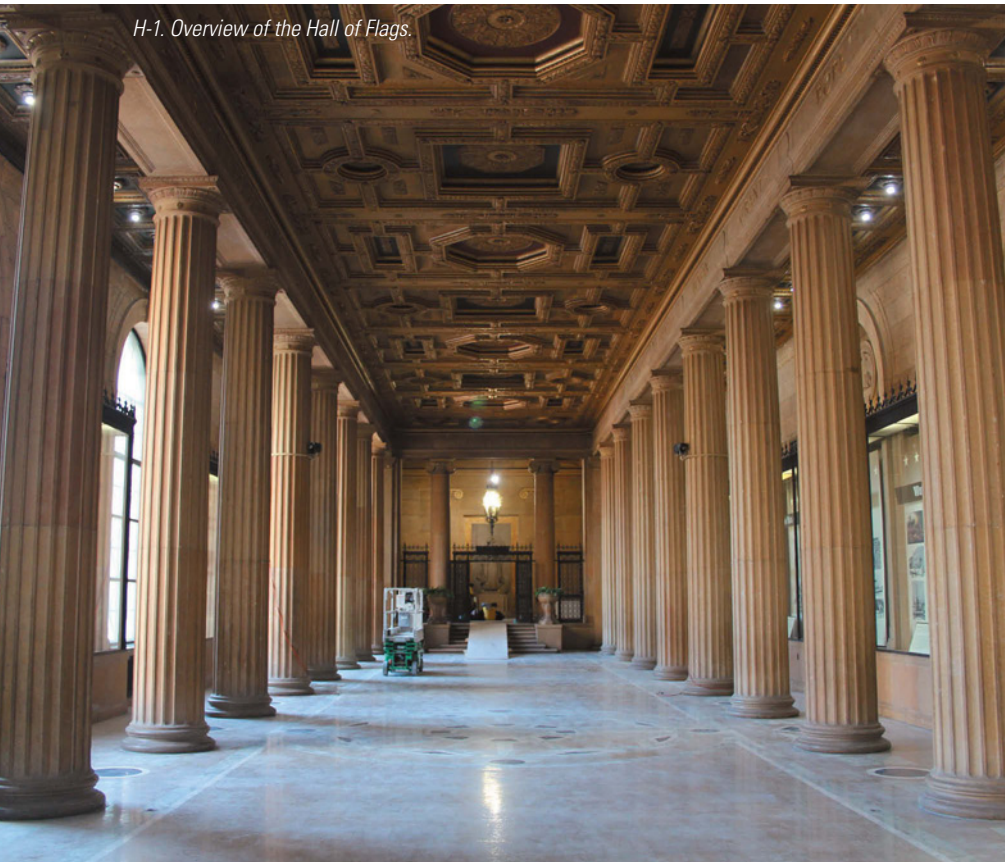
On June 26, 2012, one bay of the decorative gilded plaster ceiling in the Hall of Flags collapsed and fell approximately 30 feet to the floor. Fortunately, building staff had noticed cracks in the ceiling the day before, and the room was unoccupied at the time. No structural distress, moisture infiltration, or outside influences were observed or reported that could have led to the ceiling collapse.

H-1. Overview of the Hall of Flags.
