FEATURE

Terra Cotta Skyscrapers

By Edward Gerns and Anita Simon

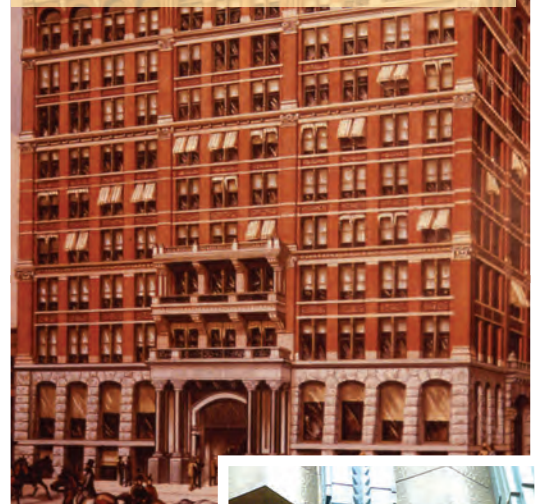
Figure 2. Home Insurance Building. Constructed in 1885 and often considered the first skyscraper (demolished). Represents the prototype of stone cladding near grade and more economical cladding materials such as brick and terra cotta above.

Prior to the 1930s, Chicago skyscrapers were typically clad with a combination of masonry materials including stone, brick, and terra cotta. Since one of the early uses of terra cotta was an economical alternative for stone, the glaze developed during its manufacture was intended to replicate stone. Terra cotta was now being used on the upper floors of the new taller building (Figure 2). Visually, the terra

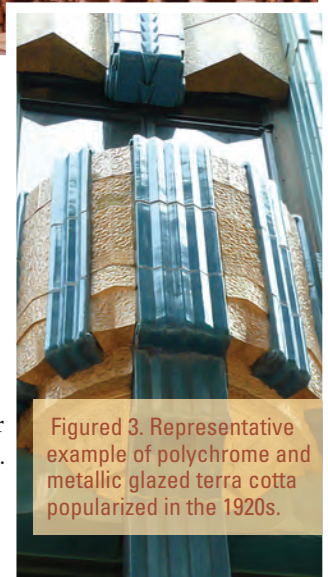
Figure 3. Representative example of polychrome and metallic glazed terra cotta popularized in the 1920s.

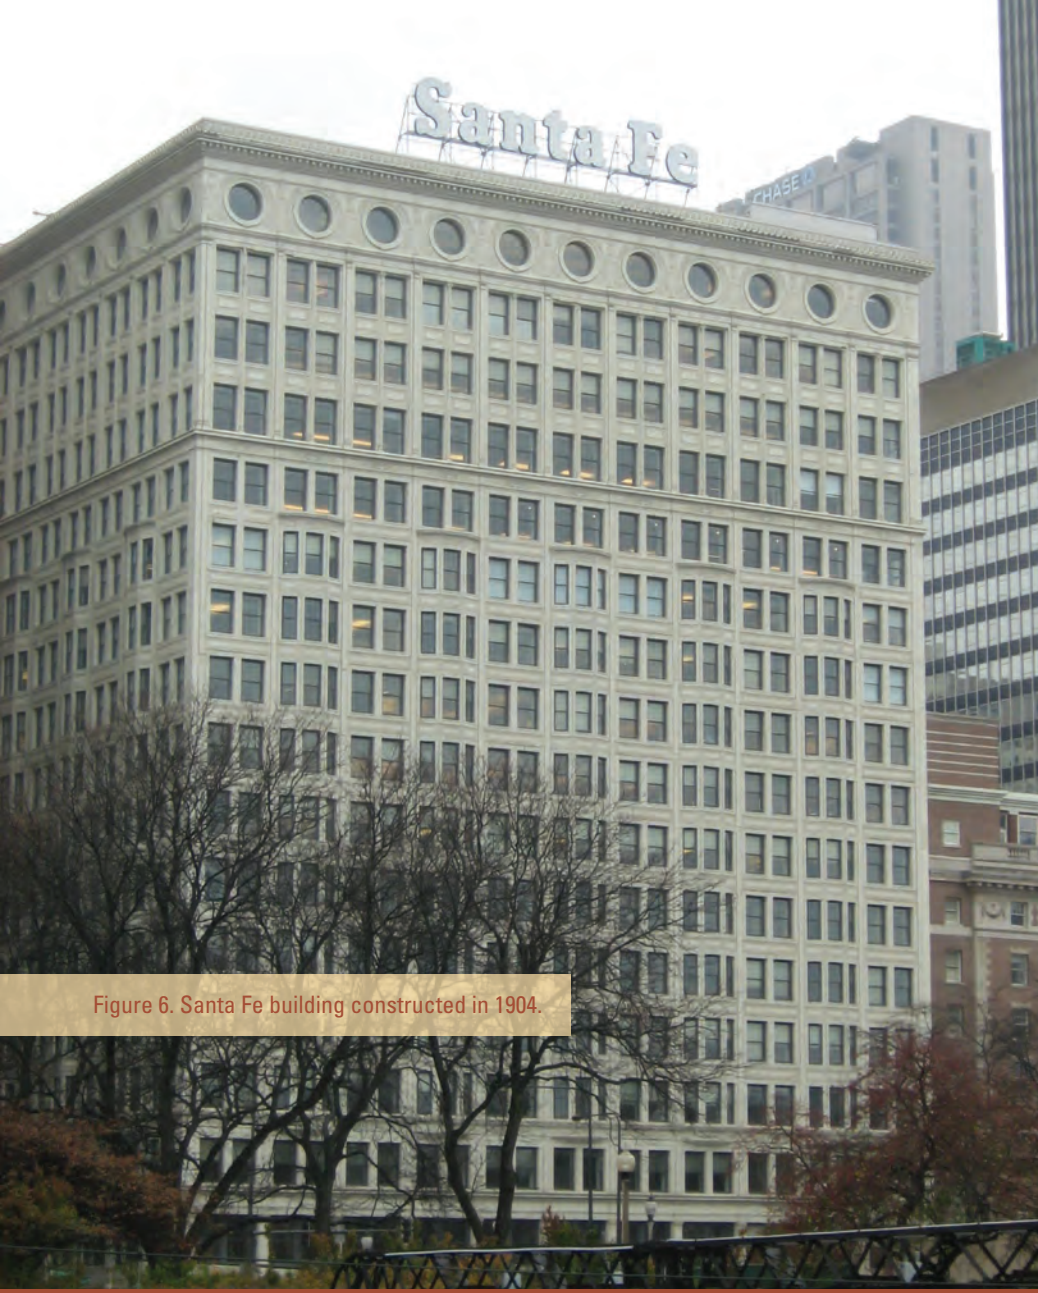
Figure 6. Santa Fe building constructed in 1904.

Designed by architect Daniel Burnham and constructed in 1904, the Santa Fe building represents an example of a white vitrified glazed building (Figure 6). The building is 16-stories tall and the two street facades are clad with ornate vitrified white glazed terra cotta and aluminum frame replacement windows. The terra cotta facade of the building was constructed with numerous decorative elements including a cornice at the roof level and water tables and belt courses at the 3rd and 14th floors. The terra cotta is supported vertically by the shelf angles at each floor level. Lateral support is provided by metal wall ties that are embedded into the masonry and laid contiguous with the brick masonry backup. Terra cotta masonry above windows in the fl at areas is supported by horizontal steel dowels that are threaded through holes in the webs of the terra cotta units and through J-hooks that are hung from the steel shelf angles

Investigation revealed that while corrosion of the embedded steel was not significant, deterioration had occurred including cracking and displacements as a result of the expansive forces of corrosion by-product. The combination of initial moisture expansion, thermal cycles and frame shrinkage resulted in significant accumulation of compression stresses within the cladding system. These stresses resulted in cracking and localized displacements of the terra cotta.

To relieve compressive stresses within the terra cotta cladding, horizontal joints were cut within the piers immediately below the shelf angle at each floor. Subsequent repairs included replacement of significantly deteriorated terra cotta with new terra cotta units. Selected salvageable units were removed, repaired and reinstalled, and through-wall anchors were installed at some of the cracked units for stabilization purposes. Finally, due to a combination of conditions, all of the terra cotta units at one of the corners were removed, the embedded steel repaired, and the corner was reconstructed with a combination of new and salvaged units.

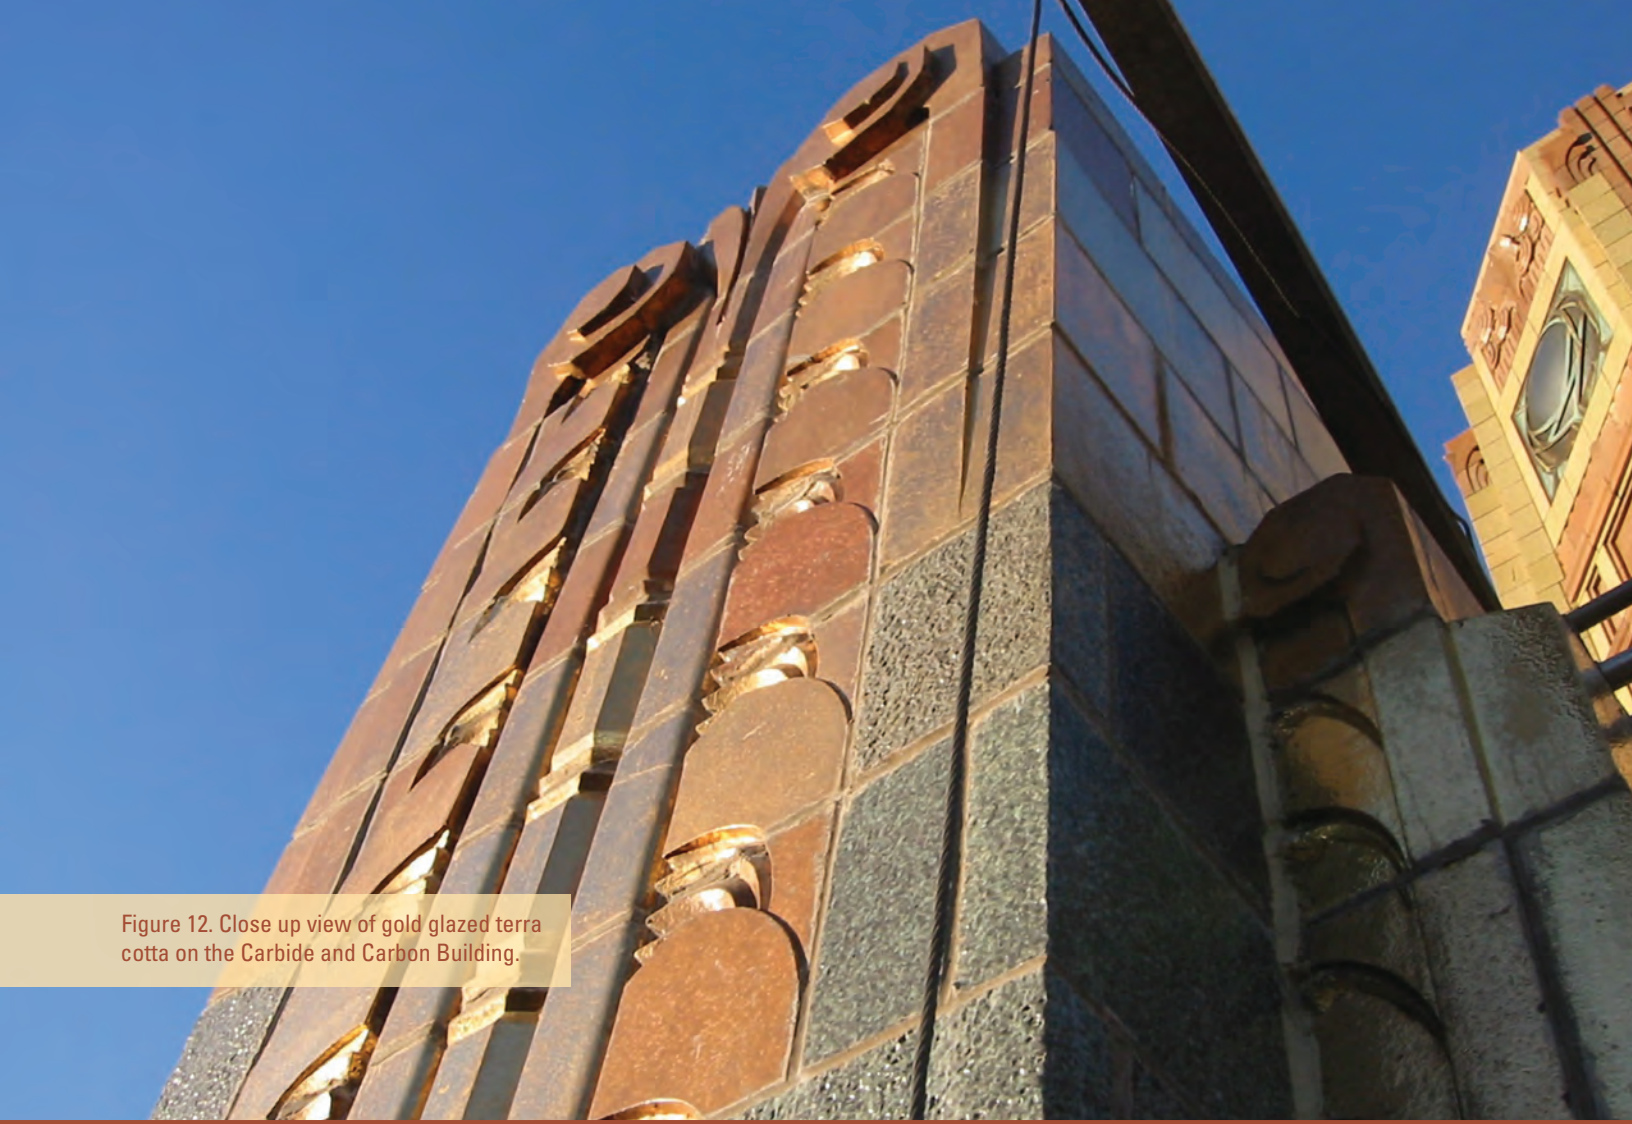
Figure 12. Close up view of gold glazed terra cotta on the Carbide and Carbon Building.
