PROJECT PROFILE

Mission Espada North Gate

Historic Preservation and Structural Repair Design | San Antonio, TX

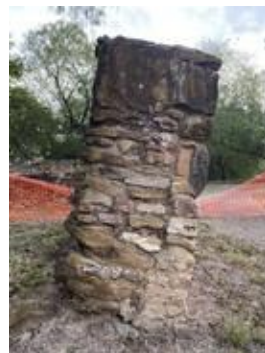
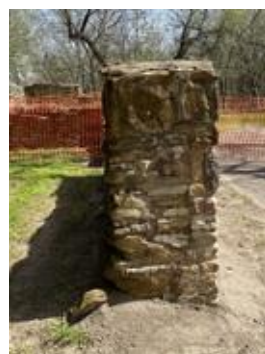
Over time, both the west and east sections of the North Gate wall feature had developed a southerly lean with the east wall leaning 11.23 degrees by 2019. Due to its rotation, the west wall section had developed a two-inch crack between its east-end pier and its wall body.

Our design included protective lumber cribbing to cradle the wall during rotation, calculations for the placement and attachment of hydraulic jacks and counterweights, and the careful placement of below-grade fill materials along the south wall, including the addition of landscape fabric to isolate the new work from the colonial foundation. Repairs to the west wall crack and minor stone loss that developed during the rotation were made with NPS-approved compatible cement-lime mortar.
