PROJECT PROFILE

UTSA, Arts Building

Concrete Beam and Floor Repair | San Antonio, TX

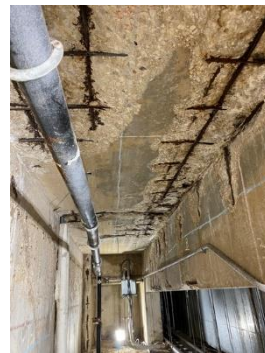
To determine the root cause of the distress, WJE and a contractor removed areas of the distressed concrete and took core samples of the concrete for laboratory analysis. The core samples were sent to our laboratory in Austin, Texas, and the Janney Technical Center in Northbrook, Illinois, for evaluation. The evaluation confirmed through carbonation and chloride analysis that the likely root cause of the concrete distress was the leaking water softeners.

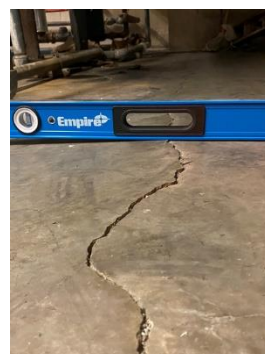
Based on this assessment, our repair design consisted of removal of all unsound concrete, including the entire slab and portions of the supporting beam, and cleaning of all corroded reinforcing. Carbon fiber-reinforced polymer was used to replace the compromised beam shear capacity around severely corroded shear stirrups, and galvanic anodes were used to protect the reinforcing steel from future corrosion.
