**HEAVY MOVABLE STRUCTURES, INC.
TWENTIETH BIENNIAL SYMPOSIUM**

**Structural and Mechanical Construction
Details for Replacement of a
Bascule Span Superstructure with Minimal
Impact to Rail & Marine Traffic**

Chuck Davis, PE
Scott Bridge Company

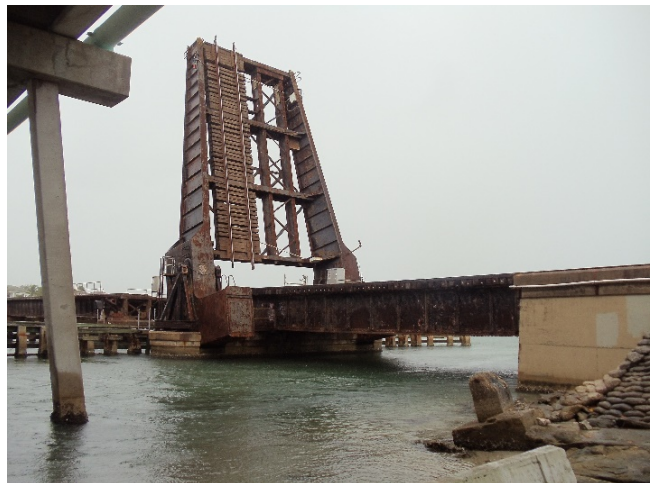
Existing Bascule Span in the Raised Position

The bascule span was replaced in 1935 when the original span was struck by a train. The span was of riveted construction, consisting of four lines of steel stringers and four floorbeams that frame into two main girders of built-up I-shape construction in the forward section and counterweight box heel ends.

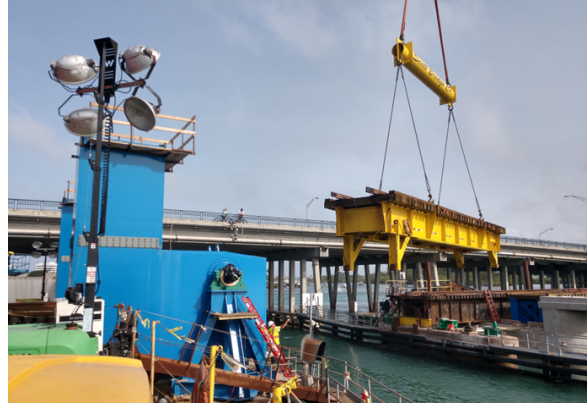
Flying jump span being removed from the channel

The FJS utilized W44 rolled beams with continuous cover plates on the top and bottom flanges needed to increase the strong axis inertia for this deflection-driven design. In addition, special bearings were designed and fabricated to bear on the existing narrow heel pier and toe pier bridge seats. A unique delta frame brace was added below the span at each end to transfer longitudinal train forces to the face of the pier.

New copper naphthenate ties were installed, and hook bolted to the span in preparation for reattaching the existing rail currently in service on the old bascule during the original 24-hour demolition outage. Lifting lugs were incorporated into the exterior web stiffeners of the FJS to facilitate quick connect and disconnect to a Manitowoc 16000 440-ton lift crane. This crane was positioned on the adjacent platform and was used to set the FJS in place and lift it out to pass boats. Spanning 55 feet over the Loxahatchee River the lifted weight of the FSJ was approximately 55 tons. In discussions with the USCG Miami office, it was agreed that the FJS would be lifted out once mid-morning and once late afternoon, 7 days per week, for one hour each during the outage to facilitate boat movements through the bridge. The railroad agreed to reschedule their freight trains to provide a reliable lift-out schedule for boaters to plan their morning and afternoon trips. Guide plates were incorporated into the lower delta frame brace and on each pier to facilitate easy and accurate removal of the span.

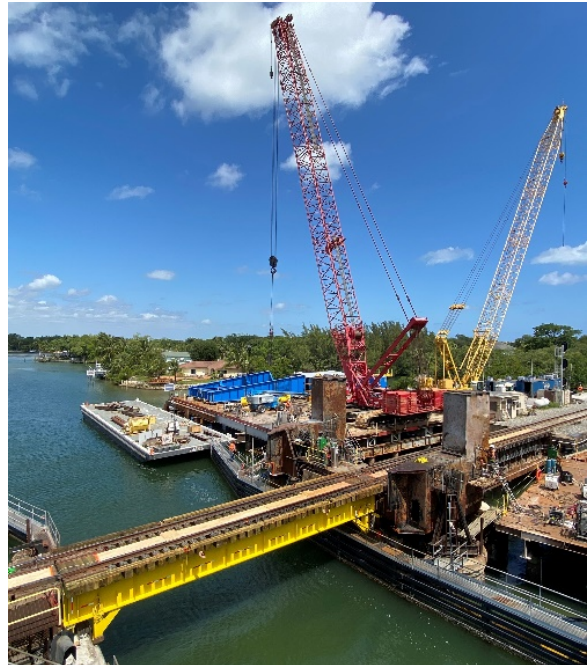
Flying jump span installed and open for train traffic

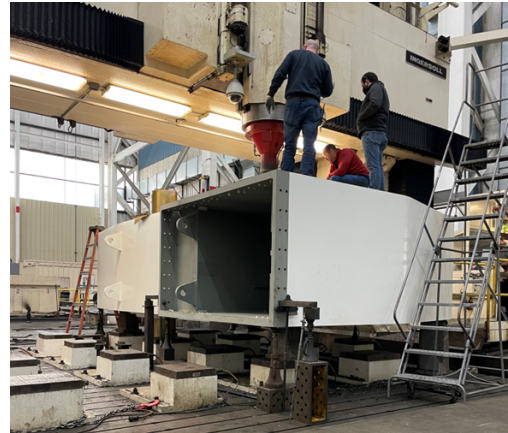
Machining a counterweight girder

The goal for the bascule leaf was to fabricate the bascule leaf accurately enough that the critical alignment of the trunnions in the girders would not be disturbed when the splice was made. G&G led the process of proposing fabrication details to achieve this goal. They changed the splice between the counterweight girders and the bascule girders from a structural connection to a machinery connection with the faying surfaces machined and tight tolerance bolts for alignment. After the main box section was fabricated, the trunnion hub bores, the rack mounting surface and bolt holes and the toe splice surface and bolt holes were all machined in one setup on their 10m gantry mill in Cordova, AL.

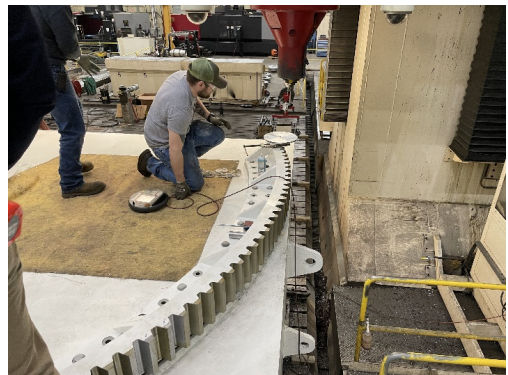
Checking rack alignment on the mill

racks relative to the trunnions after assembly of the components with the counterweight girders using two independent means: Laser tracker measurements performed by IPM and measurements performed by G&G using their gantry mill as a coordinate measuring machine. TranSystems mechanical engineers accepted this approach. The shop checks were so critical to the project that both the GC and the MBPC attended the checks to verify what measurements were taken before approving installation of the final turned bolts in the shop.

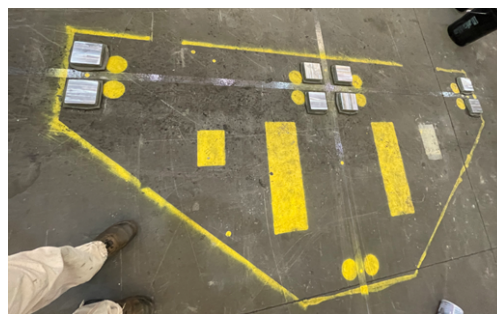
Layout of sole plates to support towers at shop assembly

- Sole plates that would support the towers were laid out and grouted in place.
- The sole plate elevations were surveyed with a laser tracker, and then shim packs were made up so that the top of the shim pack was at a precise elevation, ready to accept the towers and open gear frames.

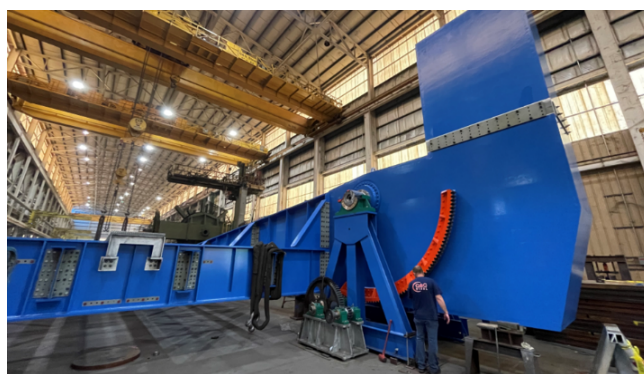
Completed shop assembly of leaf supported on towers

The shop assembly was witnessed by the GC and the MBPC, and independent verification of critical alignments was done via laser tracker measurements performed by IPM. The shop assembly was successful, and no major changes were made to the plan for field assembly.

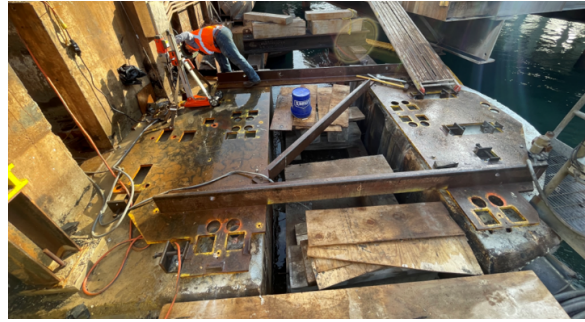
Tower template installed on bascule pier

A single steel template was used for the two towers and one open gear frame on each side of the bridge. The template was set in place, precision aligned using a laser tracker and anchored in position. The template had features to locate:

- Anchor bolt holes, which were drilled with core drills.
- Kicker fixtures that were anchored to the pier with mechanical anchors.
- Sole plates that would support the towers and open gear frames until they were grouted.

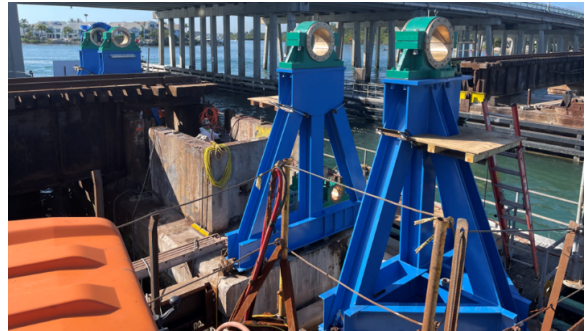
Towers installed and aligned on pier

After removal of the templates, the sole plate elevations were surveyed with a laser tracker and then shim packs were made up. The towers were then installed on the sole plates and shim packs. All four towers were set in a similar manner. Elevations were verified with a laser tracker and minimal adjustments were needed. The laser tracker was then used to adjust the four bearings into precise alignment.

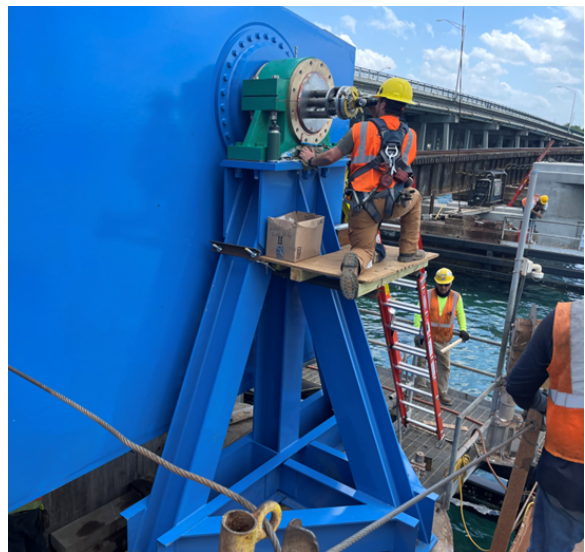
Checking trunnion alignment after setting counterweight girders on towers

The trunnions were aligned to within .010-in., half of the specified tolerance. The towers were grouted at this stage and the anchors tightened. In preparation for the second rail outage, the counterweight boxes were filled. As this loaded the towers, the trunnion alignment was monitored. The increased load also caused the girder to rotate as the support deflected. Prior to the outage, the girder was adjusted so that the splice was vertical to a high level of precision.

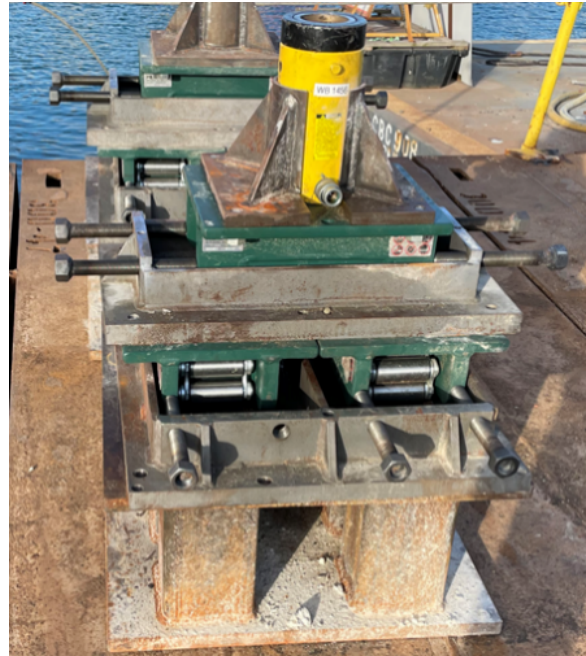
Manipulator to aid alignment of toe section

The toe section had been pre-assembled on the adjacent work platform and was lifted and swung into the channel, landing on the manipulators within inches of final position. The position of the toe section was adjusted with the manipulators relative to the counterweight girders until both gaps closed and all splice bolts could be installed by hand.

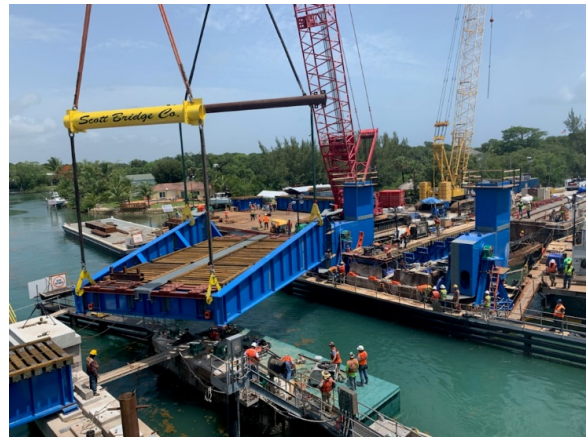
Lifting toe section into place
